<b>KSANDER &amp; ASSOCIATES</b> STRUCTURAL CONSULTING ENGINEERS  (705) 743-9221 Ksanders@bellnet.ca		Stratton Residence - 2357 Lakeshore Road, Douro-Dummer Existing Foundation and framing review	
Date: Mar 13, 2024		Scale:	
Designed by: RK		Drawing: <b>SK-q</b>

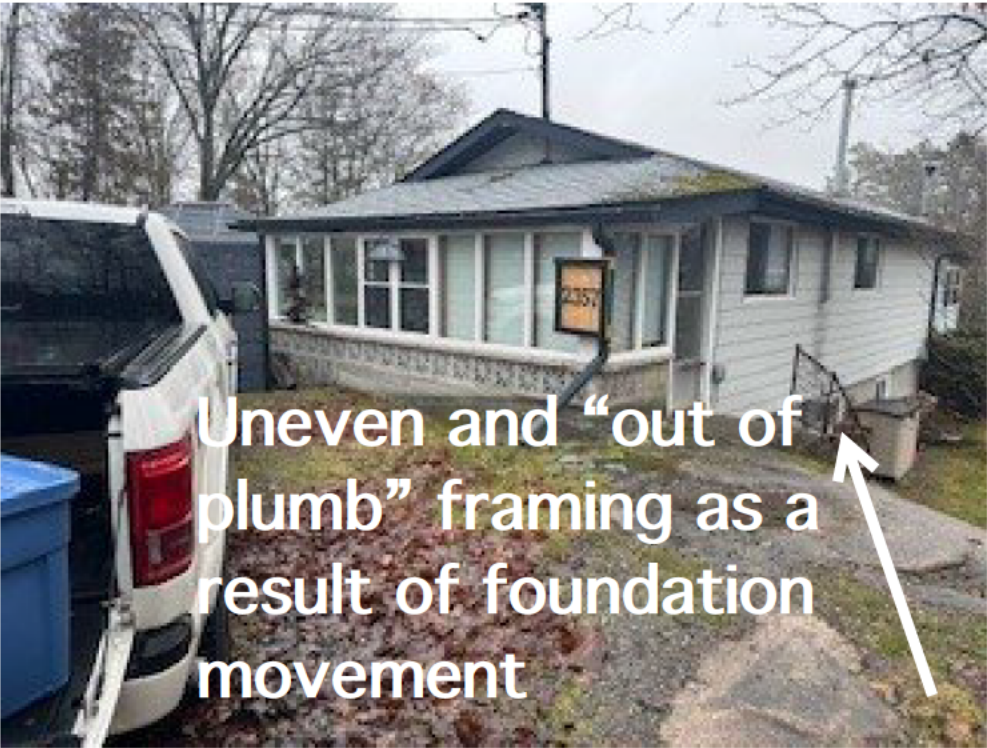
Uneven and “out of plumb” framing as a result of foundation movement

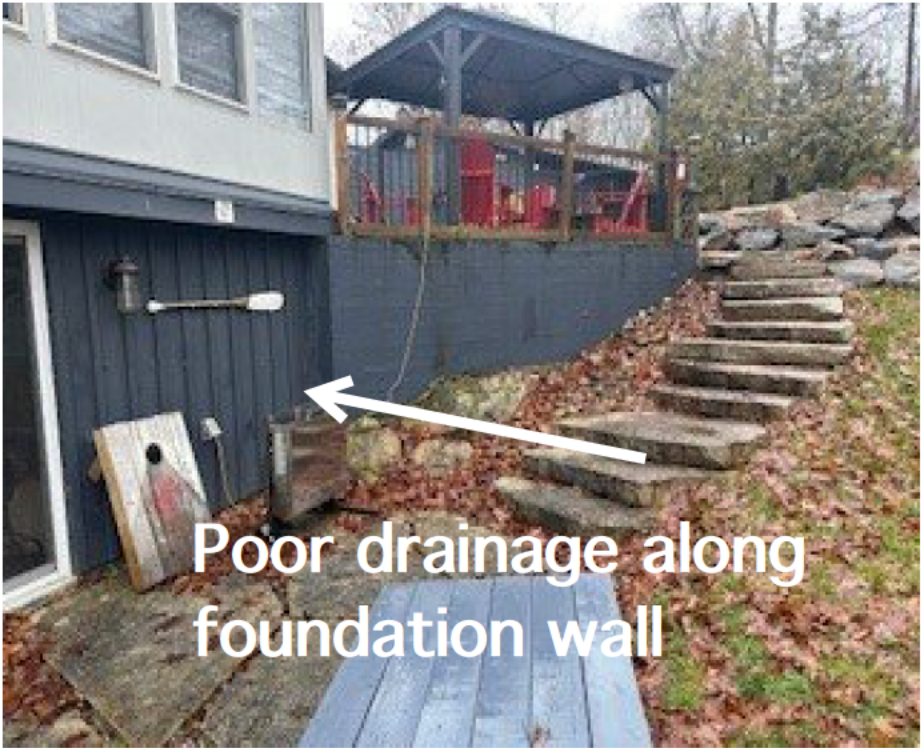
Poor drainage along foundation wall

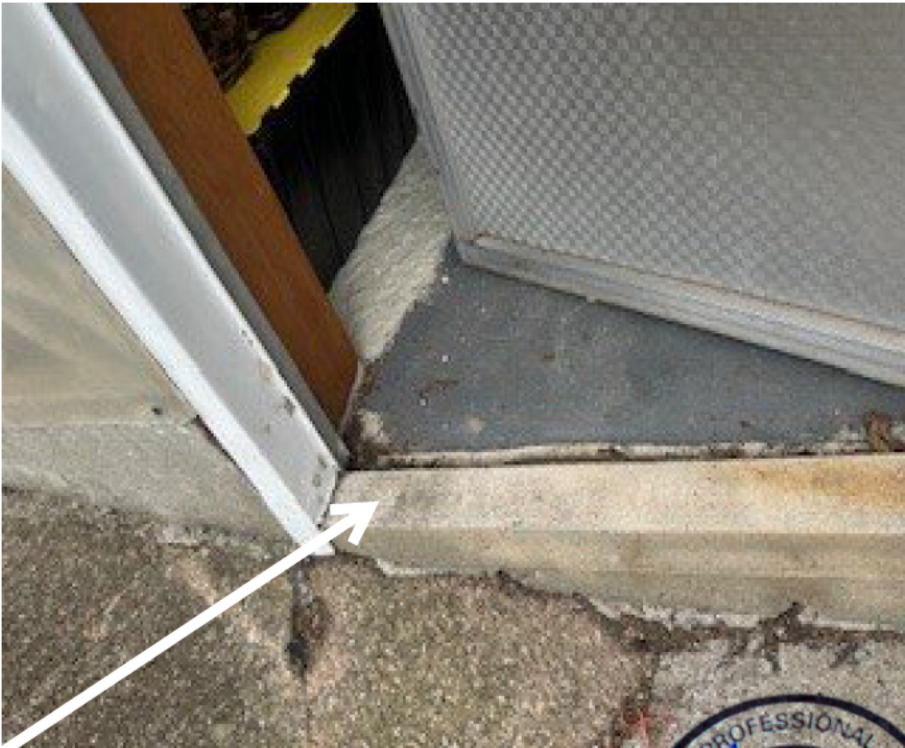
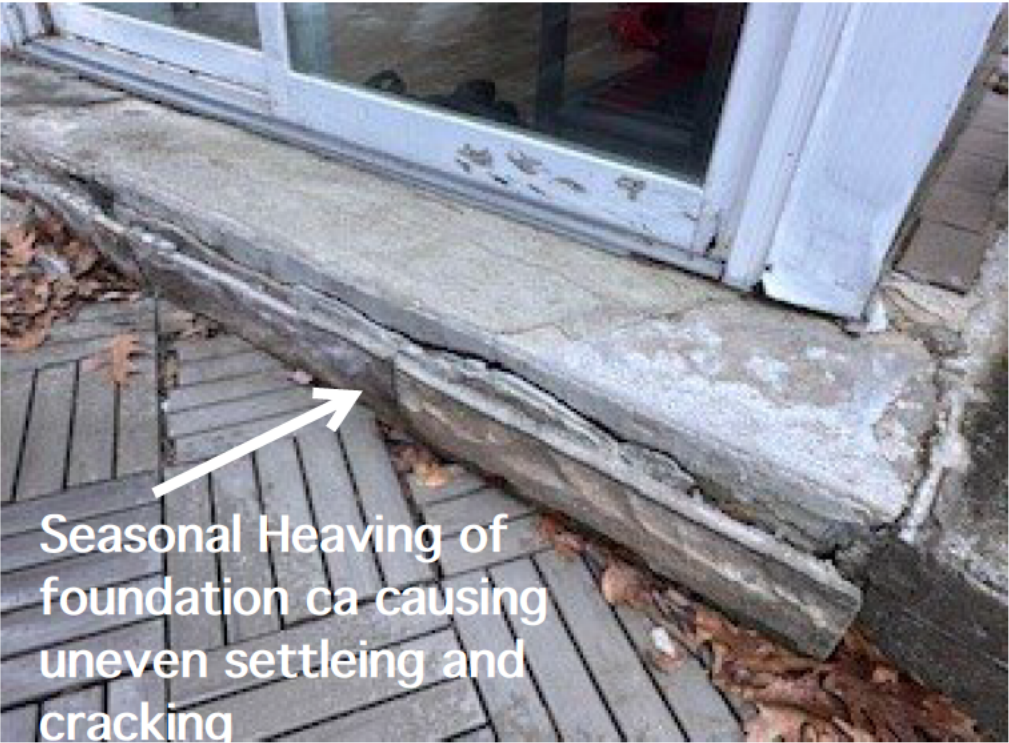
Seasonal Heaving of foundation ca causing uneven settling and cracking

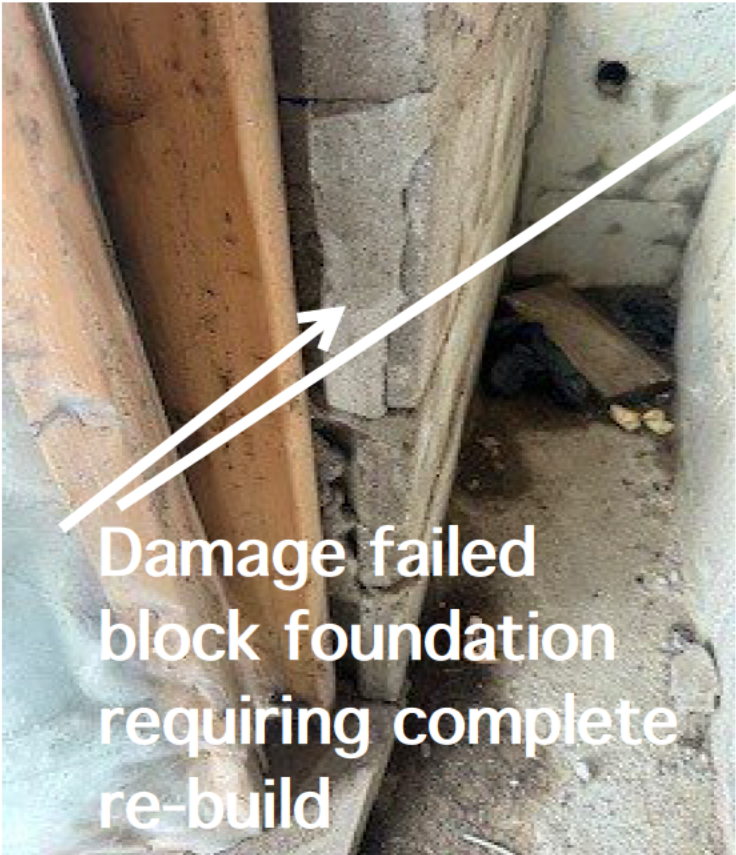
Damage failed block foundation requiring complete re-build

Review of existing residence indicates block foundation wall failure and settlement causing cracks and wood rot. Repair would require complete re-build for foundation and framing above which I believe would not be practical in this case. Replacement suggested.

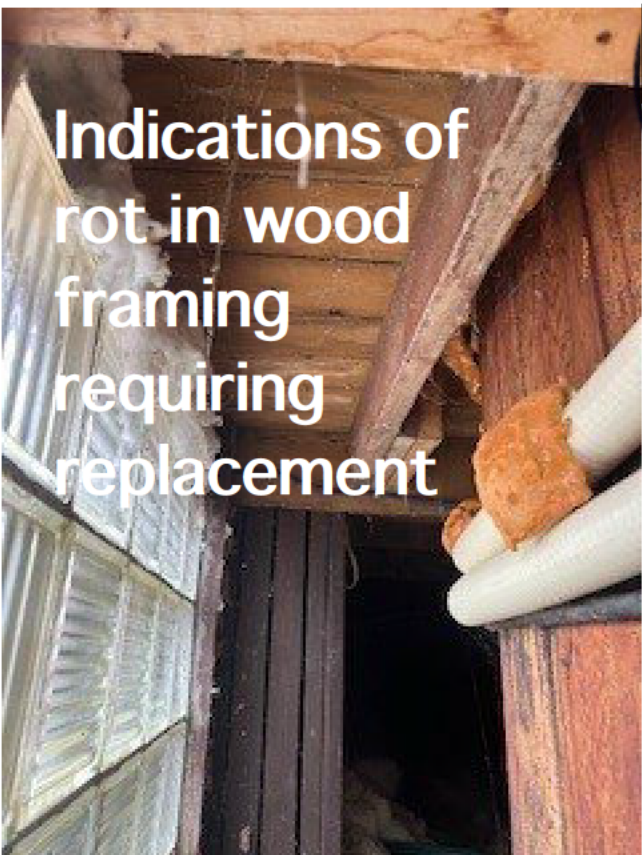
Indications of rot in wood framing requiring replacement
