# Structural Condition Assessment – Old Irwin Inn 2-Storey Dwelling – 1386 Irwin Road, Lakefield

November 7, 2025

Prepared for:  
Christina Laing and Aaron Goldstein

Cambium Reference: 21537-001

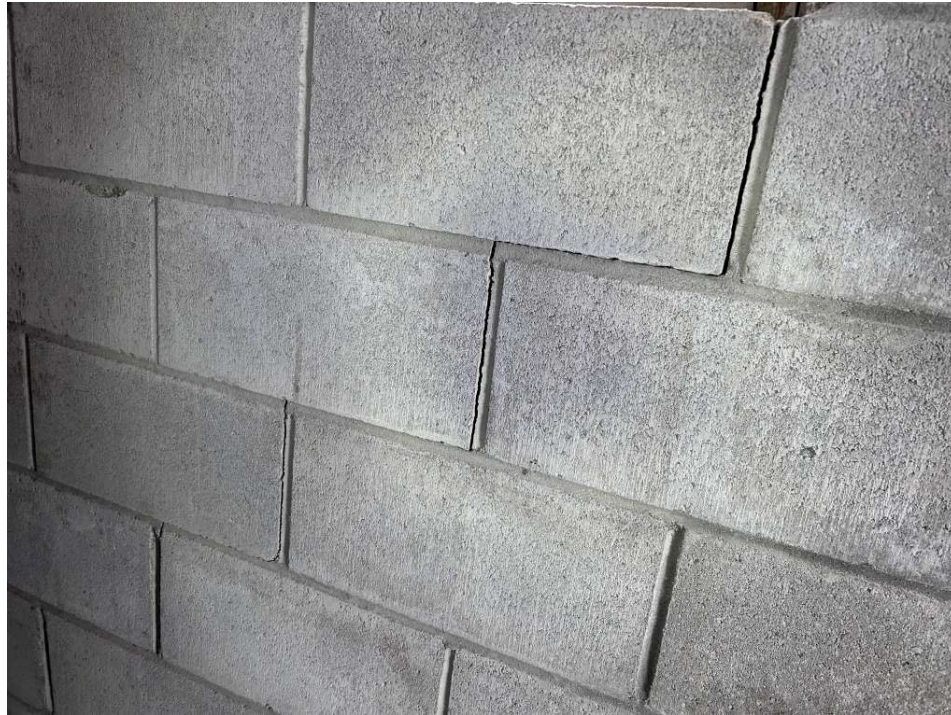
**Photo 1: Ref No. S01**

Ref. No.	Deficiency	Recommendations	Location	Photo Ref.	Condition	Priority	Probable Cause(s)	Consequences of Deferred Action
S01	Step-cracking in concrete block wall	Deficiency will be rectified upon demolition and reconstruction	Irwin Inn - Basement - West wall	1	Fair	Low	Settlement below foundation wall	Severity of cracking likely to worsen, more extensive repair/replacement project required
S02	Wood log column not fully bearing on concrete pad; no anchorage between column and foundation	Deficiency will be rectified upon demolition and reconstruction	Irwin Inn - Basement	2	Poor	High	Construction deficiency	Potential movement and localized failure at raised deck structure
E01	Missing exterior wall cladding and weather barrier	Deficiency will be rectified upon demolition and reconstruction	Irwin Inn - North and East walls	3-4	Poor	High	Temporary sheathing installed after partial demolition	Structural damage to wood-framed structure

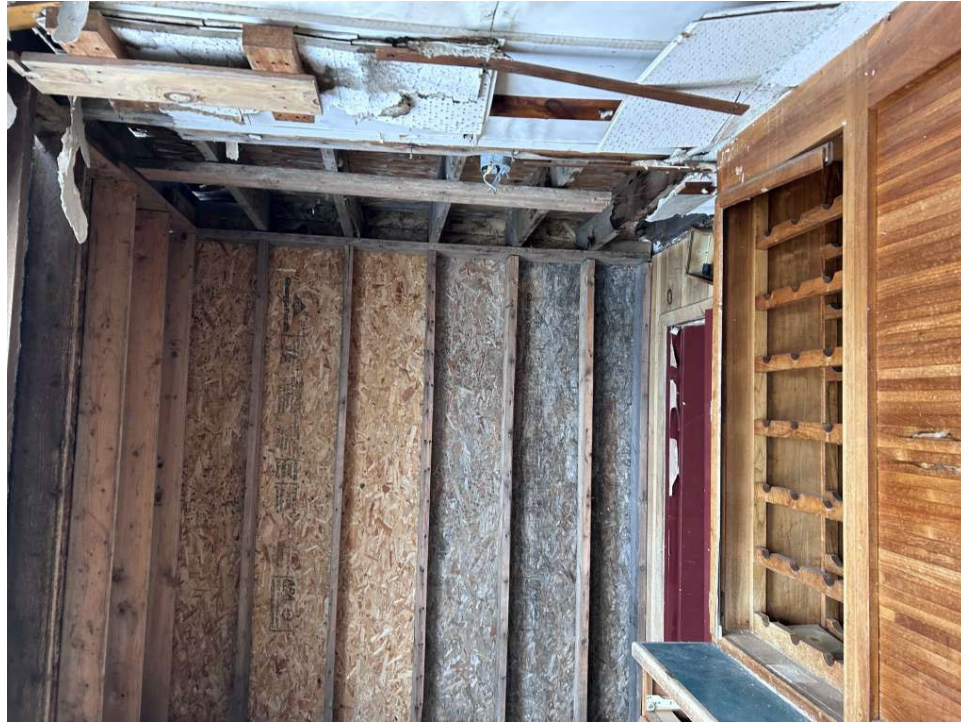
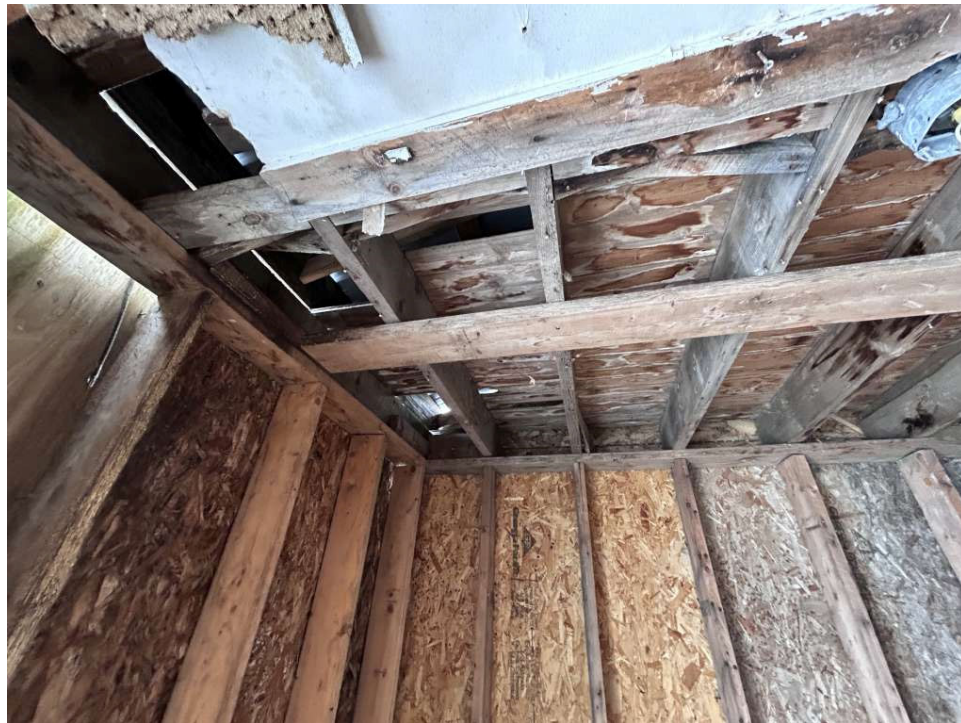
E02	Missing insulation and vapour barrier at exterior walls and ceiling/attic	Deficiency will be rectified upon demolition and reconstruction	Irwin Inn - Level 1 and 2	5-6	Poor	High	Building unsealed after partial demolition, rodent infestation	Structural damage to wood-framed structure
E03	Mould on ceiling and exterior walls	Investigate - Designated Substances Assessment for disposal recommendations - asbestos, lead, silica, mercury	Irwin Inn - Level 1	7-9	Poor	High	Building unsealed after partial demolition, snow melt and rain infiltration to interior	Structural damage to wood-framed structure
E04	Vertical crack at mortar and masonry veneer below window sill	Deficiency will be rectified upon demolition and reconstruction	Irwin Inn - West side	10	Fair	Medium	Differential settlement after construction at concrete block wall	Potential crack dimensions increase
E05	Broken window pane	Deficiency will be rectified upon demolition and reconstruction	Irwin Inn - Main floor - Northwest corner	11-12	Poor	Medium	Impact damage, no maintenance since building is not operational	Injury, pest access, exposure to elements, water leakage

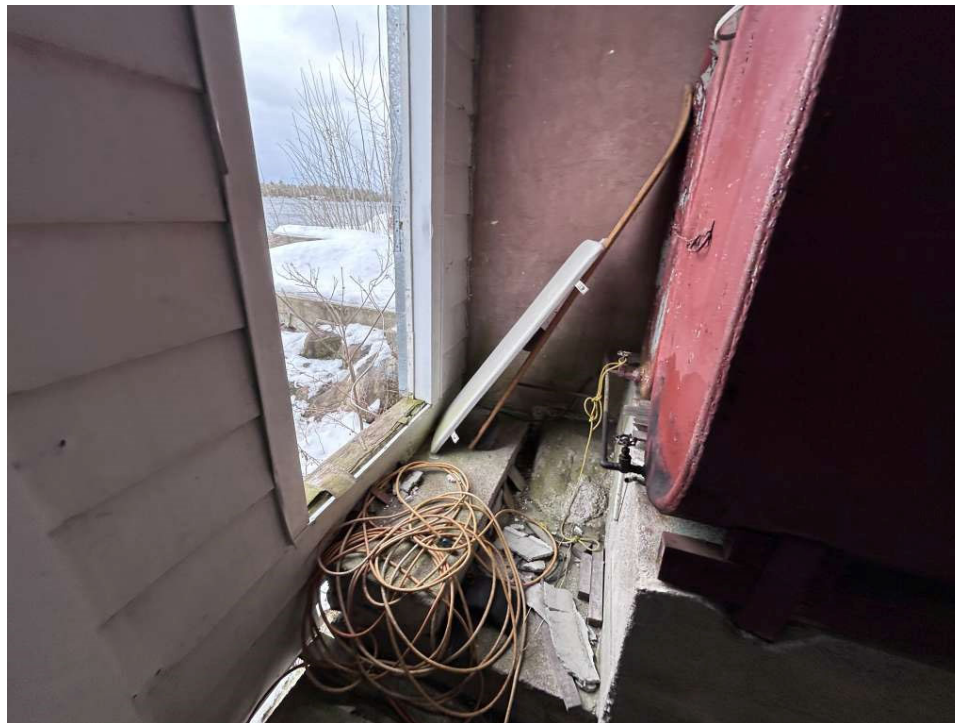
**Photo 13: Ref No. E06**

E06	Exposed door opening	Deficiency will be rectified upon demolition and reconstruction	Irwin Inn - Basement - North side	13	Fair	Low	No maintenance since building is not operational	Injury, pest access, exposure to elements, water leakage
E07	Roof leaks, missing/damaged insulation and vapour barrier	Deficiency will be rectified upon demolition and reconstruction	Irwin Inn - Throughout	14-18	Poor	Medium	Building unsealed after partial demolition, snow melt and rain infiltration to interior	Injury, pest access, exposure to elements, water leakage
E08	Exterior wall openings	Deficiency will be rectified upon demolition and reconstruction	Irwin Inn - Throughout	19-20	Poor	Low	Building unsealed after partial demolition	Injury, pest access, exposure to elements, water leakage
