**Re: Slope Stability Inspection at 1182 Birchview Road, Lakefield, Ontario**  
**Cambium Reference: CAM23286.001**

**SLOPE STABILITY ANALYSIS**  
**WELSH HOMES**  
 1182 Birchview Road  
 Lakefield, Ontario

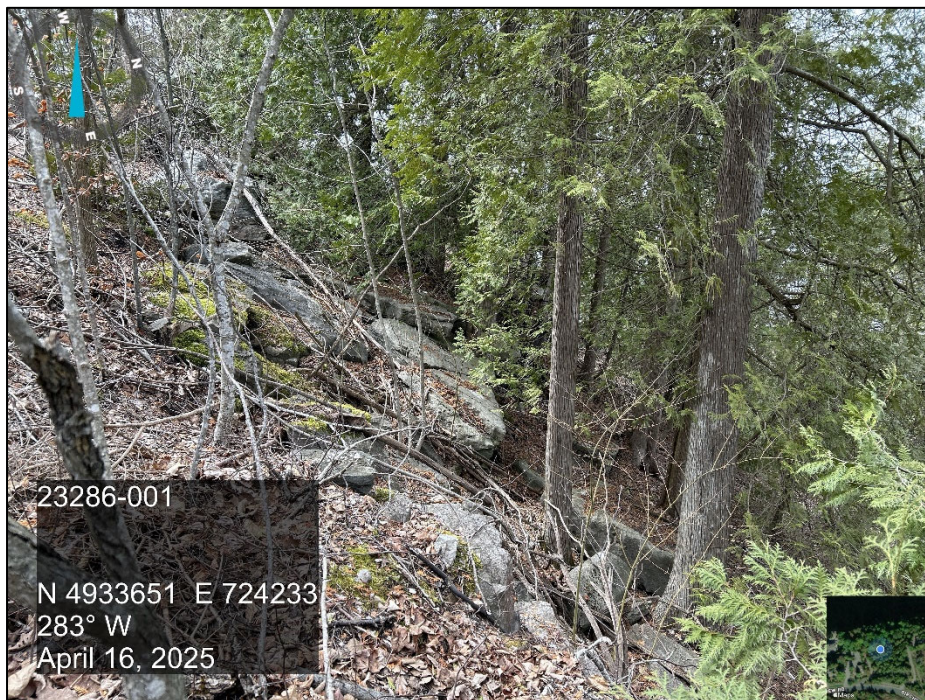
**Photo 2** View of middle slope face near Cross Section A-A, looking west, showing loose surficial boulders and mixed mature trees.

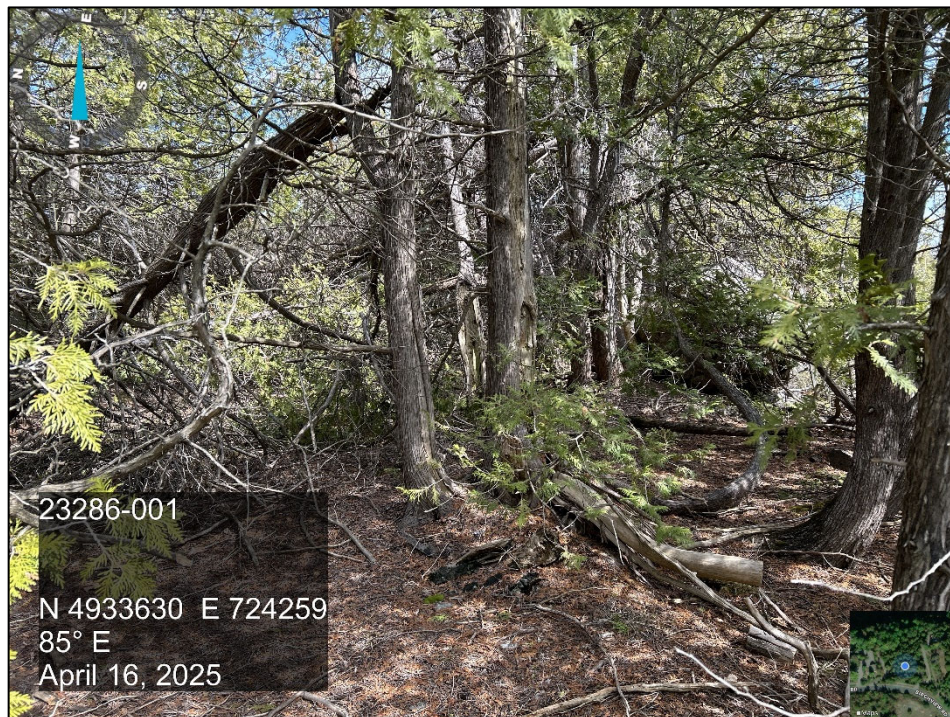
**Photo 6** View of the top of slope at the upper slope at Cross Section B-B, looking east, showing mixed mature trees, and loose surficial rocks.

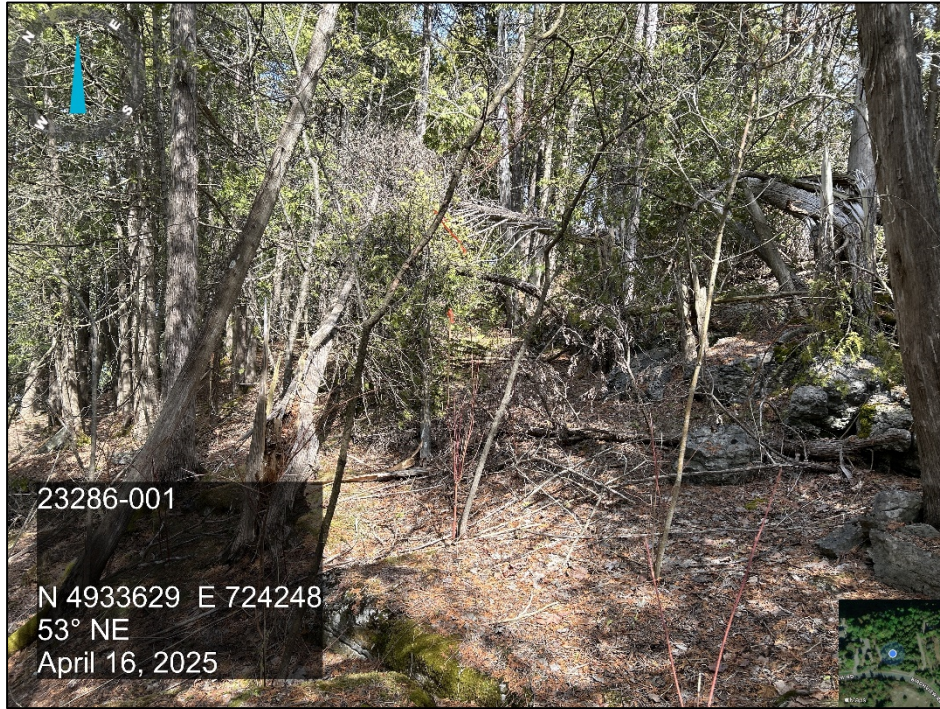
**Photo 7** View of upper slope face near Cross Section B-B, looking northeast, showing loose surficial boulders and mixed mature trees.

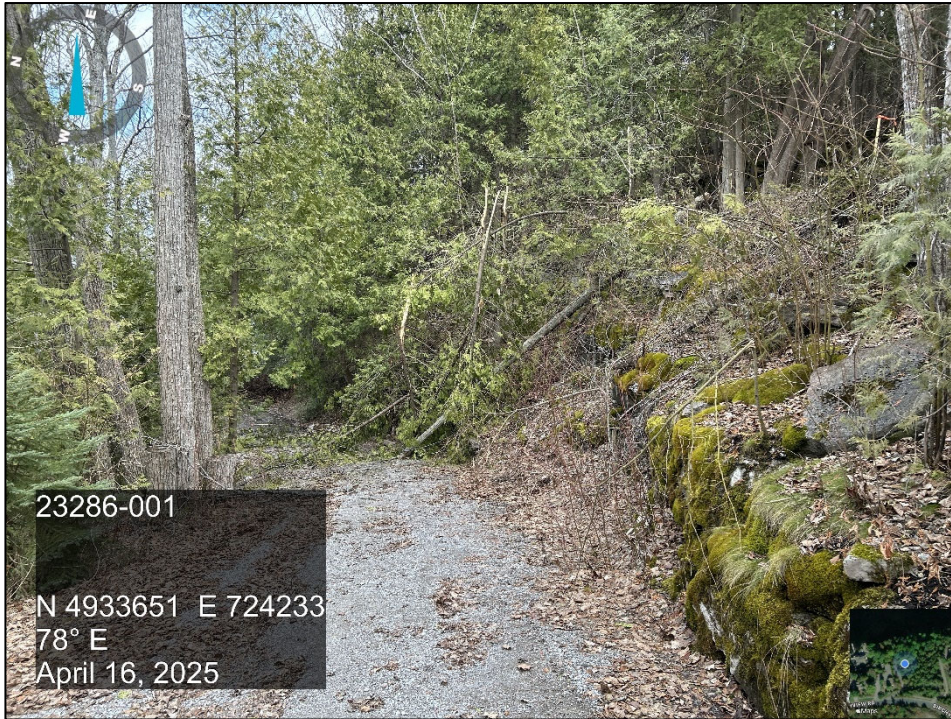
**Photo 11** View of middle slope face near Cross Section B-B, looking east, showing the driveway, exposed bedrock, and mixed mature trees.

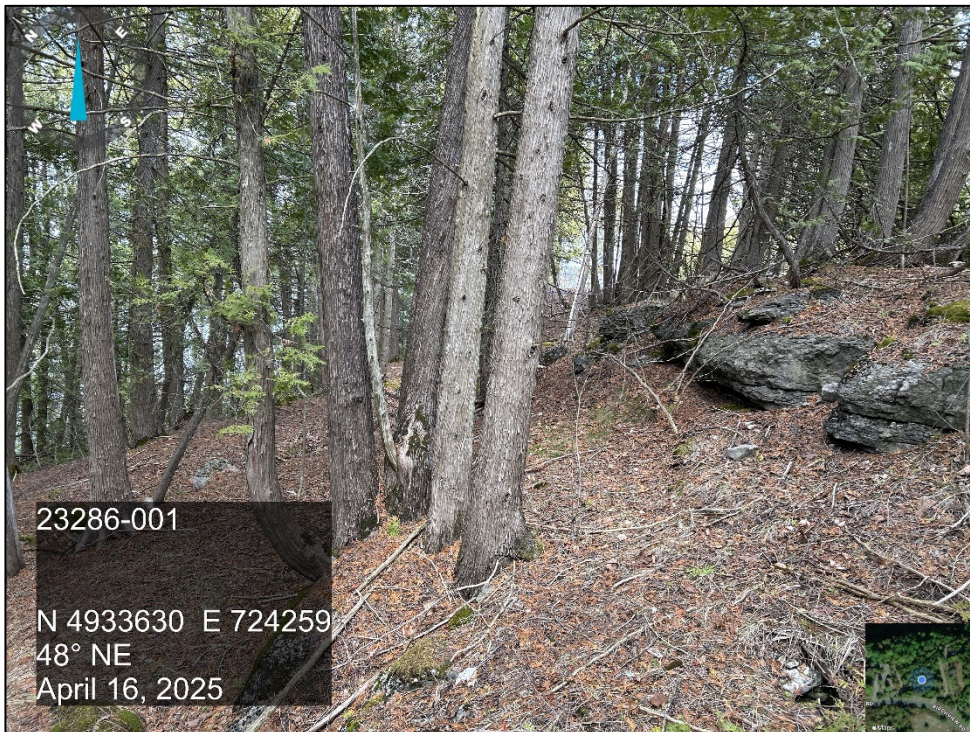
**Photo 16** View of upper slope face near Cross Section C-C, looking northeast, showing loose surficial boulders and mixed mature trees.

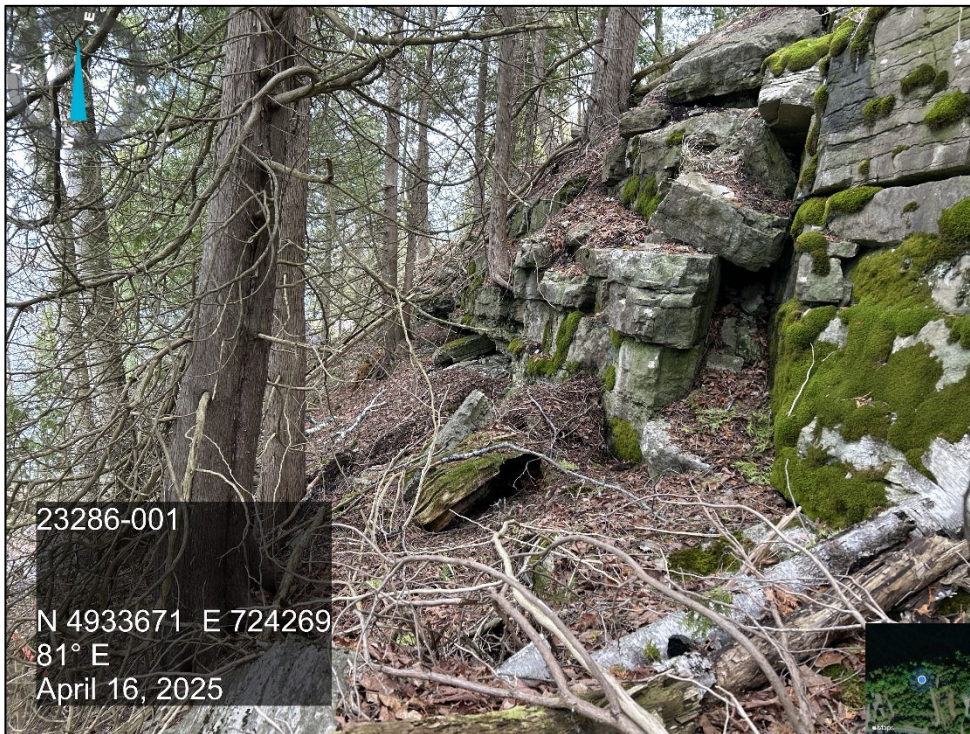
**Photo 18** View of middle slope face near Cross Section C-C, looking east, showing exposed bedrock and mixed mature trees. Loose surficial rock is evident on top of the bedrock.

- All loose, unstable, and weathered bedrock must be removed from below the proposed structures and structures must be founded on massive, unweathered bedrock.
- All loose, unstable, and weathered bedrock must be removed from slopes with inclination of 3H:1V or steeper, which are upslope of the main residential structure to prevent rockfalls into the structure.
- Where undercuts are present, the bedrock must be cut back to the furthest most point of the under cut and reshaped as outlined below.

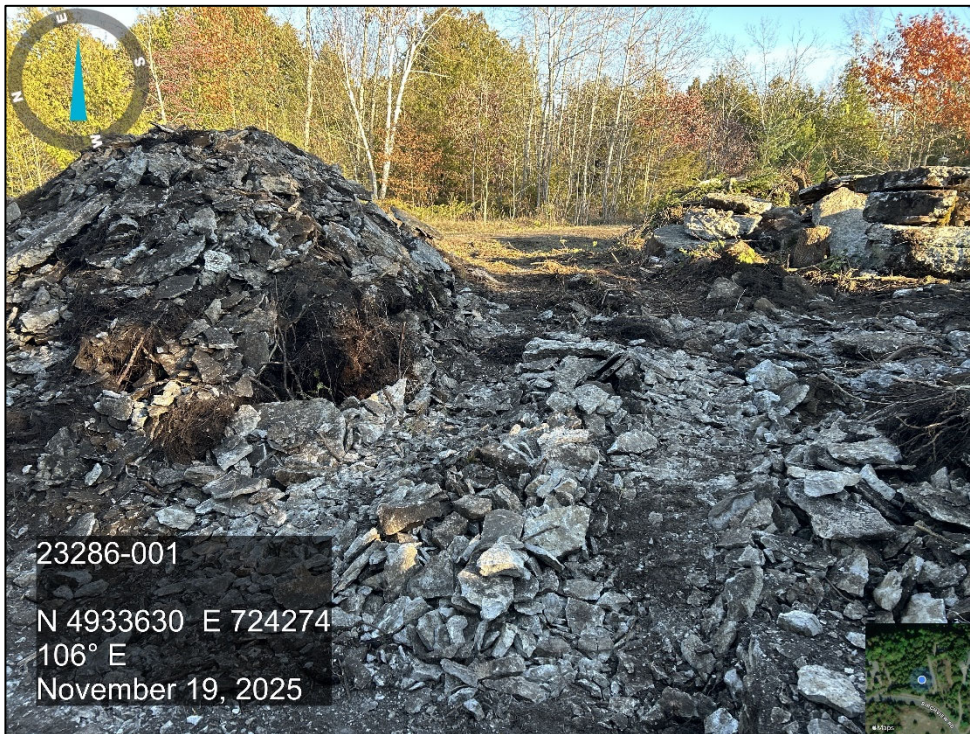
**Photo 22** View of the top of slope at the upper slope near Cross Section D-D, looking east, showing mixed mature trees, and excavated surficial rock.

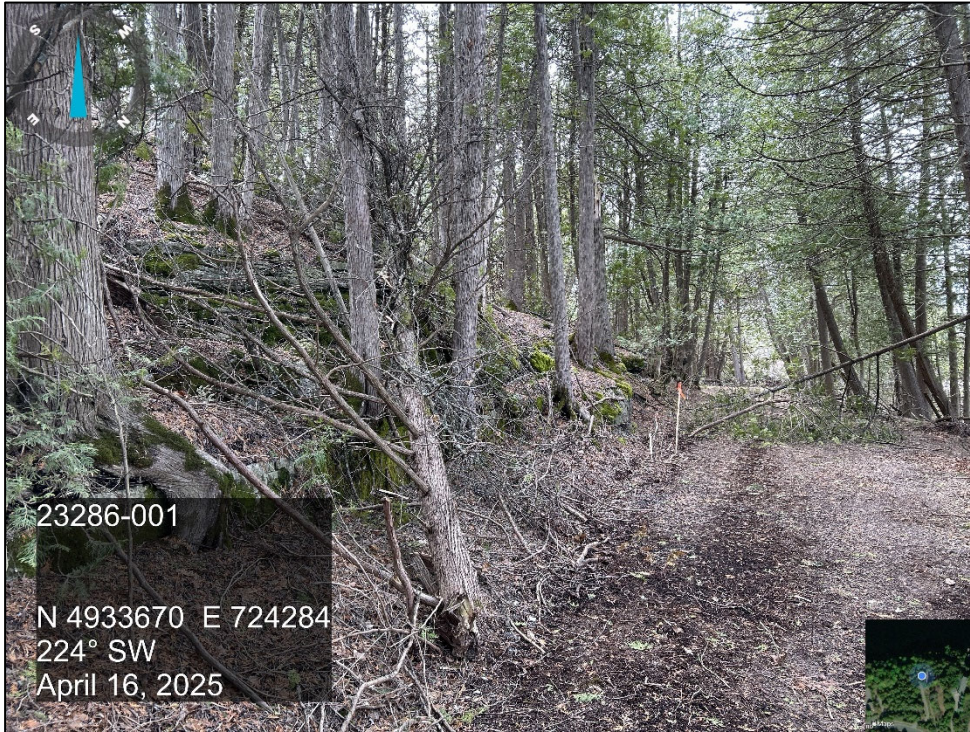
**Photo 23** View of upper slope face near Cross Section D-D, looking southwest, showing loose surficial boulders and mixed mature trees.

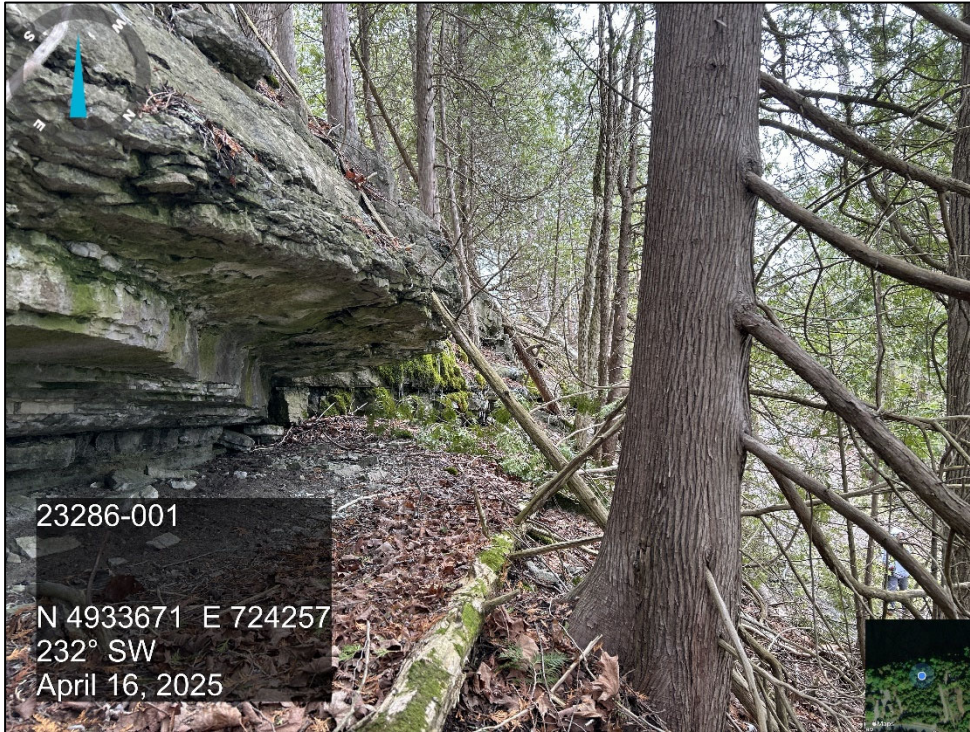
Near-vertical bedrock exposures, undercutting of exposed bedrock, and evidence of loose unstable surficial bedrock were commonly observed throughout the middle slope along with evidence of some minor rock falls. Undercutting was not observed and near-vertical bedrock exposures were found to be minimal in the upper slope however, evidence of loose, unstable surficial bedrock was common. These features were not encountered in the lower slope. Exposed bedrock was commonly observed throughout the slope. Probing inspection with a T-bar confirmed bedrock is present across the slope, with depths generally no greater than 0.3 m, except in the flat, terraced areas between slopes and immediately downslope of the undercutting, where the slope appears to be a mix of rock and soil. Depths of rock and soil are not anticipated to have a significant depth as exposed bedrock is visible both above and below. It was not confirmed visually whether the foundation of the existing building was set on bedrock.

**Photo 25** View of middle slope face near Cross Section D-D, looking southwest, showing exposed bedrock and mixed mature trees. Some undercutting was observed along the slope face.

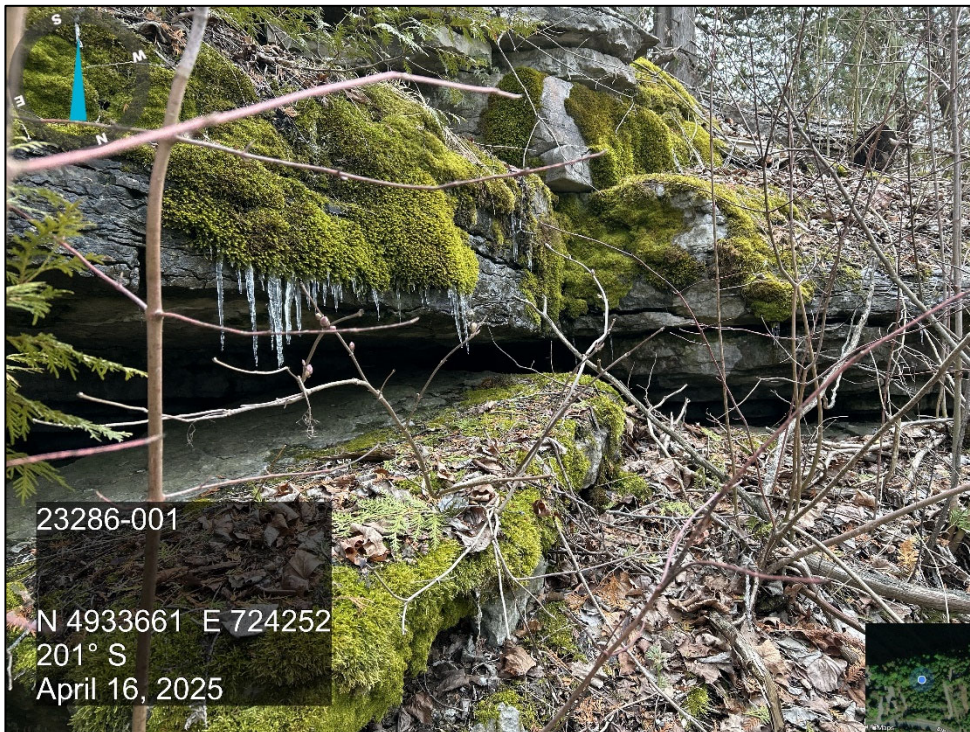
**Photo 28** Exposed bedrock along the eastern middle slope. Showing undercutting and broken shelves.

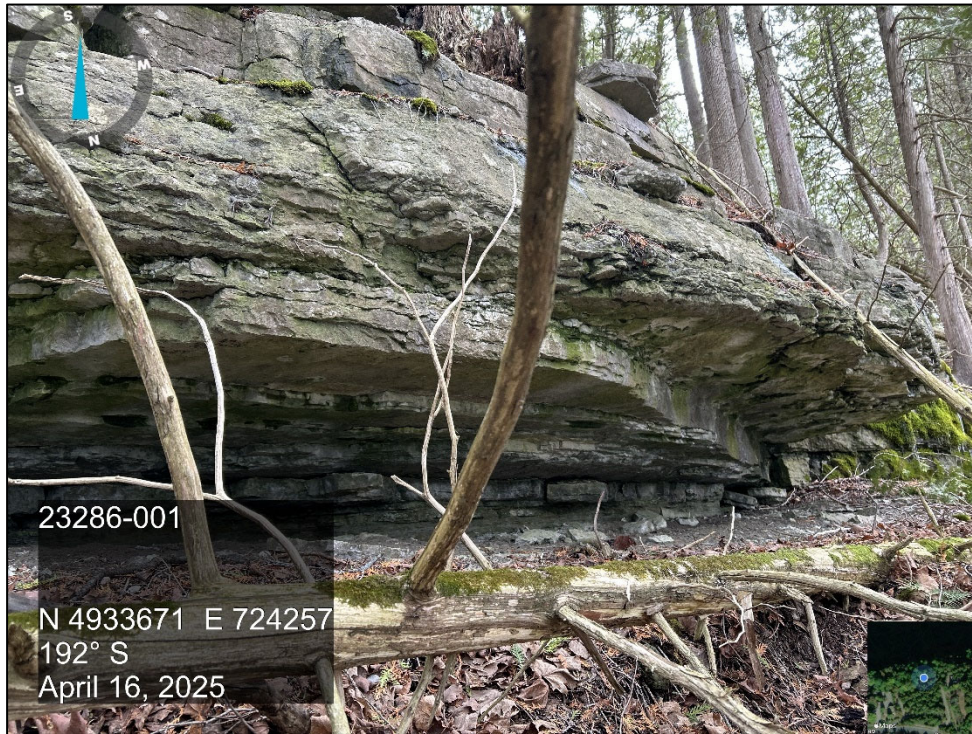
**Photo 29 Exposed bedrock along the eastern middle slope. Showing undercutting and broken shelves.**

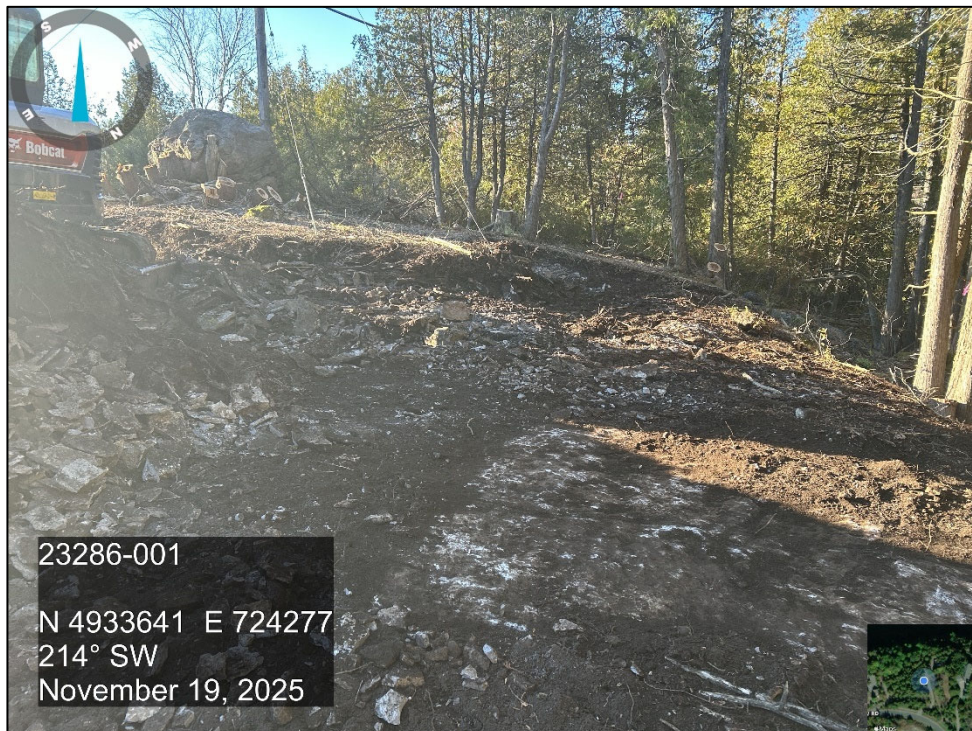
Three test pits were conducted along the top of the upper slope on the eastern slope. Several layers of loose surficial limestone were observed to overlay massive, unweathered, bedrock in each test pit location. Vertical T-bar probing was conducted into voids encountered across the site with penetration extending to depths of 600 mm to 900 mm in various locations, which was similar to the thickness of weathered bedrock at the top of the site. Lateral T-bar probing within the bedrock undercuts revealed maximum undercut depths of 1.7 m to 3 m laterally into the slope.

**Photo 30 Test pits excavated along the top of the upper slope face near Cross Section C-C. Showing limestone bedrock with few joints beneath the loose surficial rock.**
