STRUCTURAL ASSESSMENT REPORT

Project: Moore Cottage Structural Assessment

Project No.: LE-0579-25

Address: 694 Birchview Road, Douro-Dummer, ON

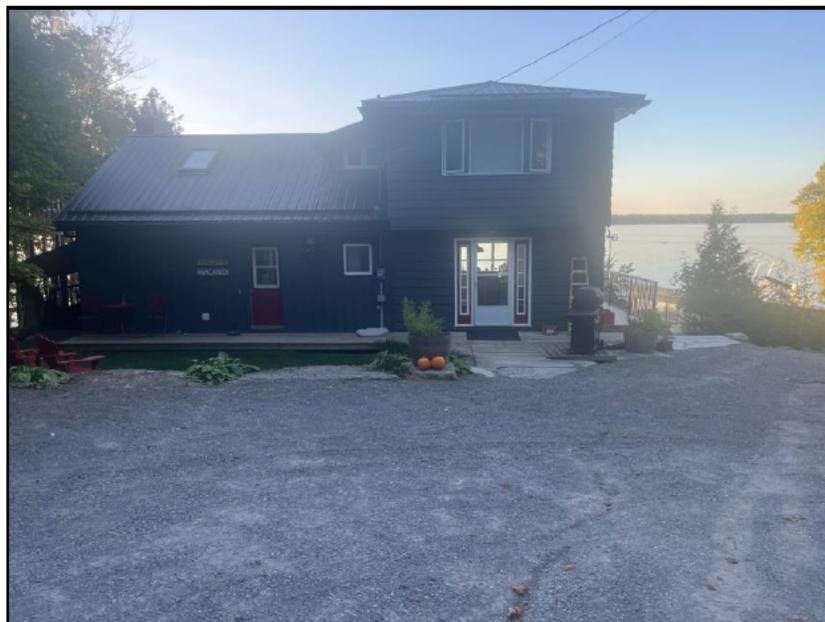
Photo 1 - Existing Cottage

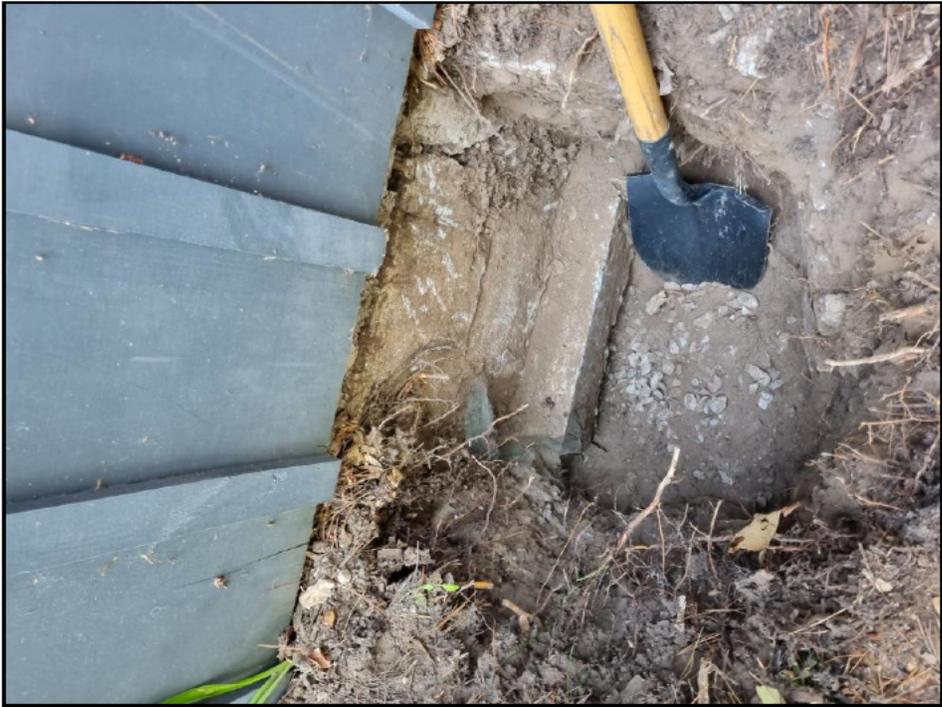
1. The concrete block foundation under the cottage is deteriorating. Lack of a frost protected foundation has led to shifting and settlement of the building which was evident inside and outside the cottage. Refer to Photo 2. The sill plates along the top of the foundation also showed extensive rot along the driveway side of the cottage where grade was highest.

Photo 2 – Existing Non-frost Protected Foundation

Based on our site observations, it is our opinion that the existing cottage, especially the foundation and building envelope cannot be repaired or renovated to a 4-season level of performance consistent with the Ontario Building Code without lifting the existing cottage and rebuilding large portions of the building. We therefore recommend removing and reconstructing the building instead of attempting to renovate or repair.

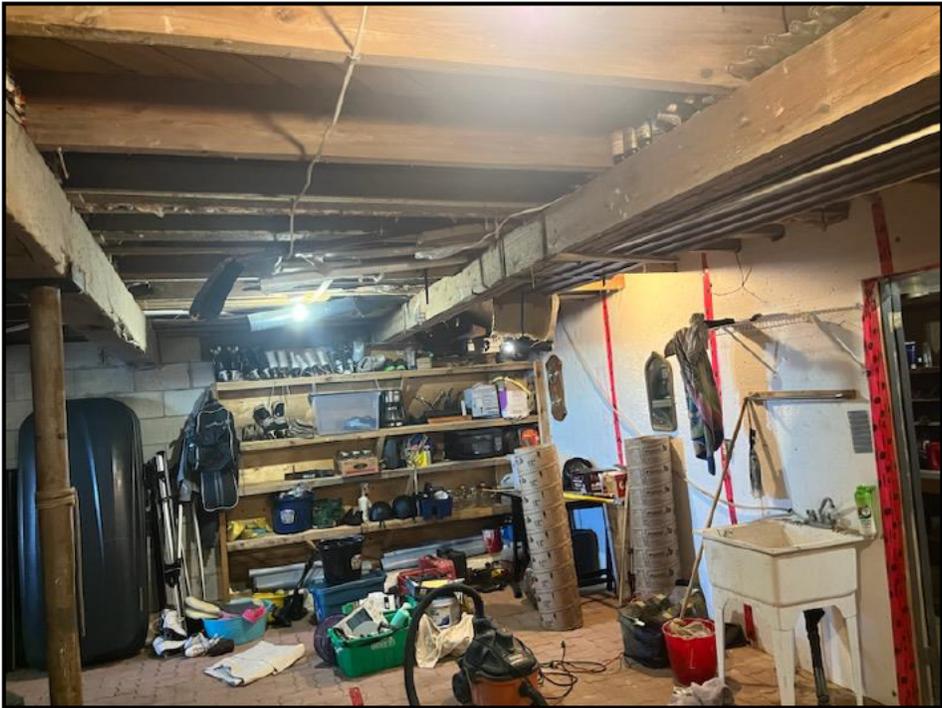
2. The main floor framing over the 16'x24' shop in the basement was structurally inadequate for current occupancy loads as specified in the Ontario Building Code due to over spanned floor beams and floor joists. Refer to Photo 3.

Photo 3 – Condition of Main Floor Framing

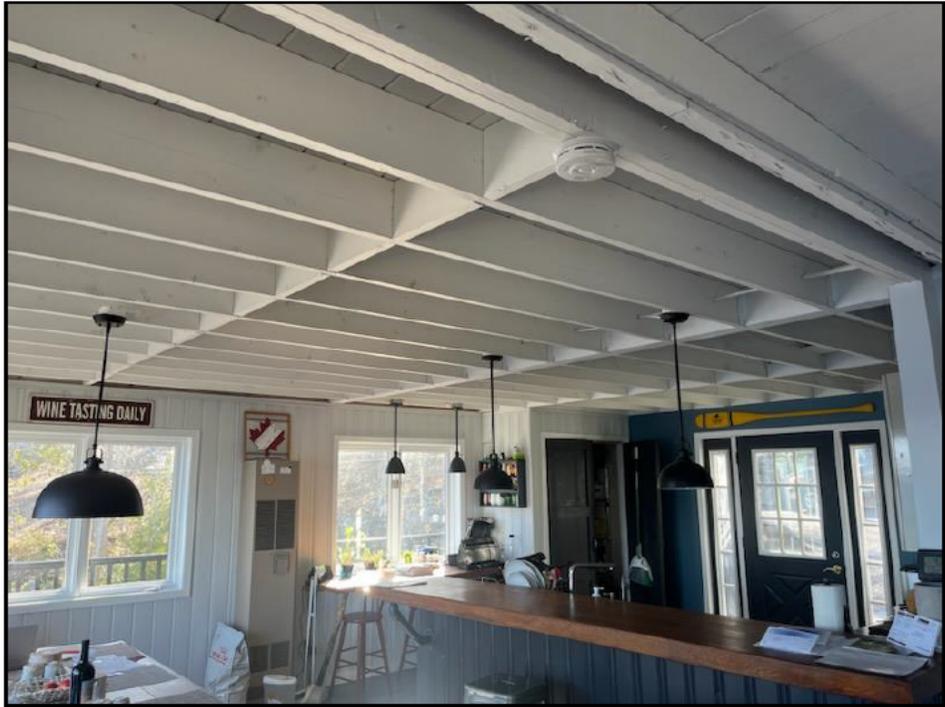
3. The floor framing supporting the second-floor area was also structurally deficient with 2x6 at 24" on center spacing spanning 12'-6" and a built-up 2x8 flush beam spanning 16'-0" while supporting 12'-0" of floor area. Refer to photo 4.

Photo 4 – Over spanned 2nd Floor Framing

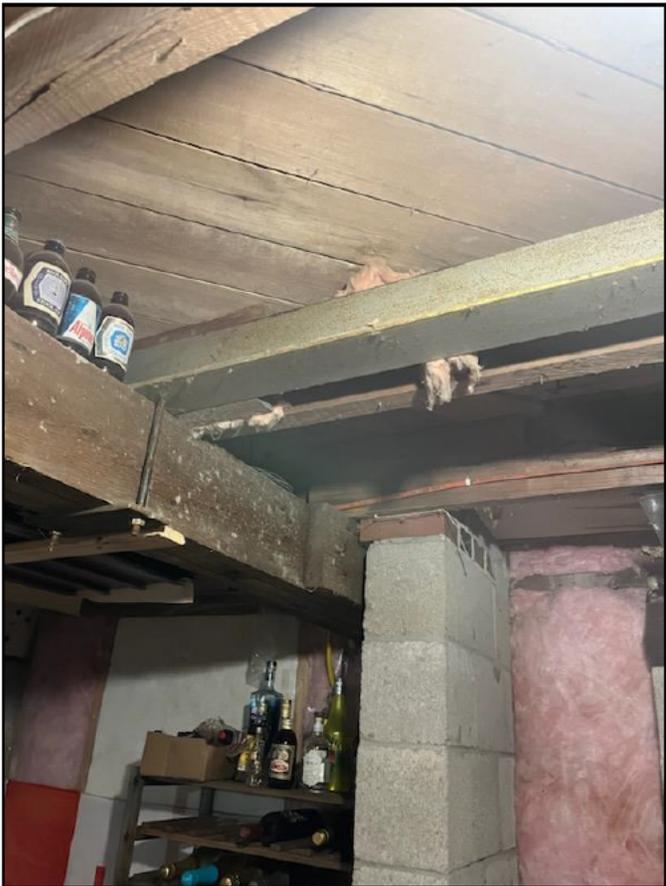
4. The lakeside deck was improperly framed using a single ply beam nailed to face of deck posts.
5. The building envelope of the cottage was in very poor condition. Lack of vapor barrier, inconsistent insulation, and old windows make any cold weather use unfeasible without moisture accumulating in the wall and ceiling cavities. Refer to Photo 5.

Photo 5 – Lack of Building Envelope
