## STRUCTURAL ASSESSMENT REPORT

**Date:** October 10, 2025  
**Project:** 1182 Birchview Rd. Cottage Structural Assessment  
**Address:** 1182 Birchview Road, Douro-Dummer, ON  
**Client:** Welsh Custom Homes  
**Distribution:** Daryl Welsh Client / Contractor [welshcustomhomes@gmail.com](mailto:welshcustomhomes@gmail.com)  
**No. of Pages:** 4 + Encl.  
**Project No.:** LE-0586-25

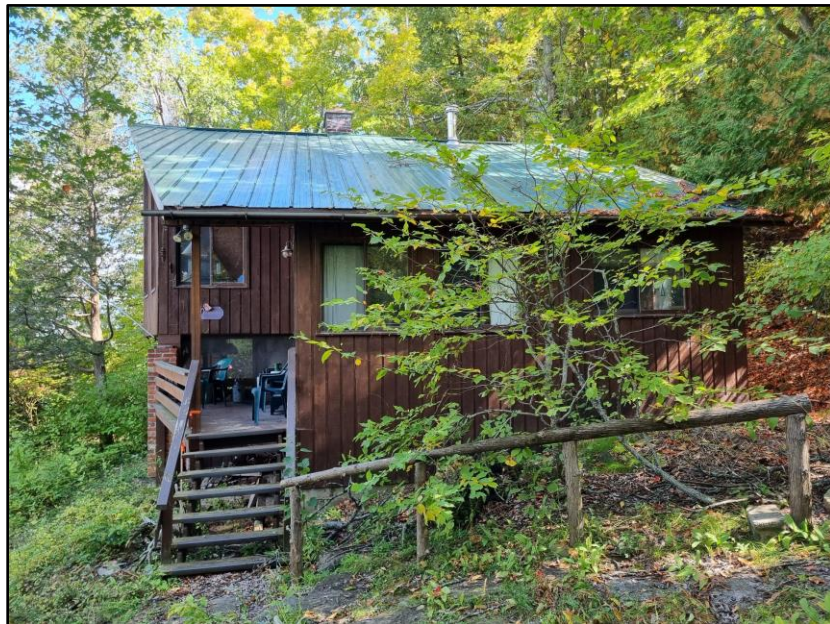
**Photo 1 - Existing Cottage**

The existing cottage structure was in overall poor condition. The primary areas of concern are noted below:

Based on our site observations, it is our opinion that the existing cottage cannot be repaired or renovated to a 4-season level of performance consistent with the Ontario Building Code without lifting the existing cottage and rebuilding large portions of the building. We therefore recommend removing and reconstructing the building instead of attempting to renovate or repair.

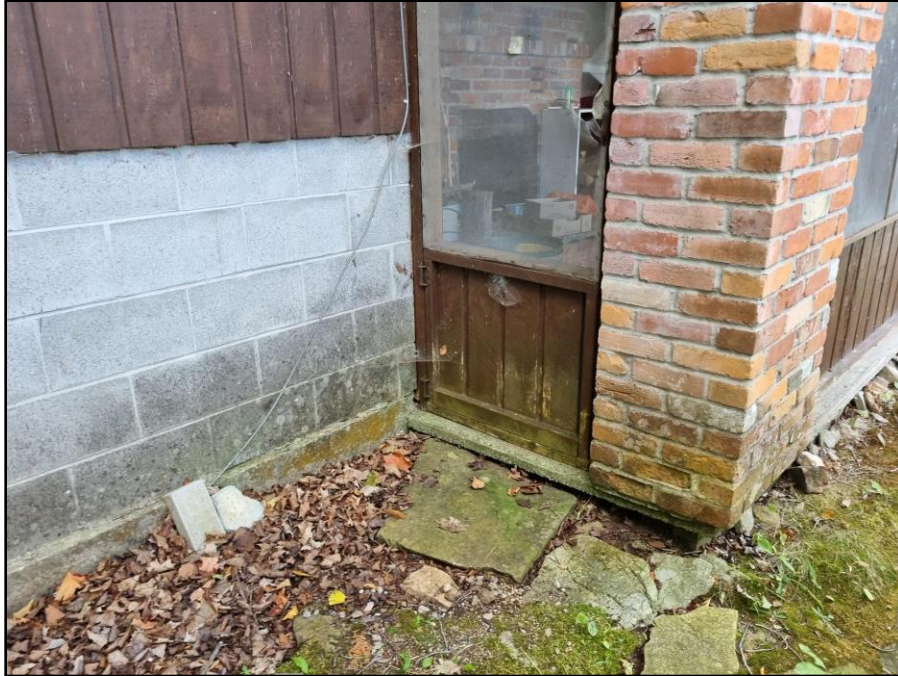
1. The concrete block foundation under the cottage is deteriorating. Lack of a frost protected foundation has led to shifting and settlement of the building which was evident inside and outside the cottage. The sill plates along the top of the foundation also showed signs of rot along the back of the cottage where grade was highest. Refer to Photos 2 & 3.

**Photo 2 – Existing Non-frost Protected Foundation**

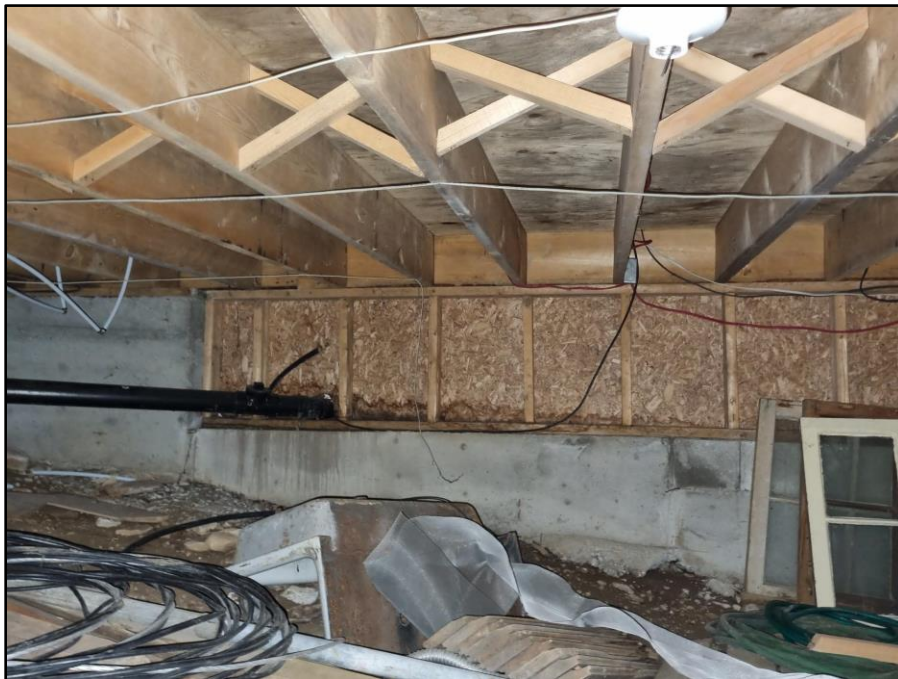
**Photo 3 – Water Damage in Crawlspace**

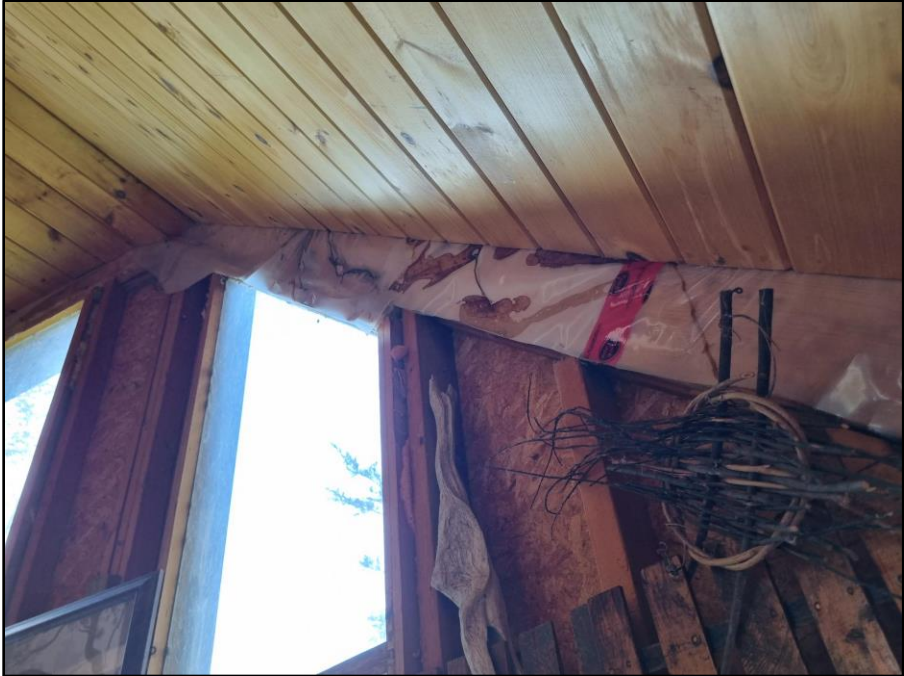
4. The ceiling showed significant water damage and water staining was evident on interior of wall framing, especially along the lakeside walls. Refer to Photo 4.

**Photo 4 – Leaking from Ceiling into Wall Framing**

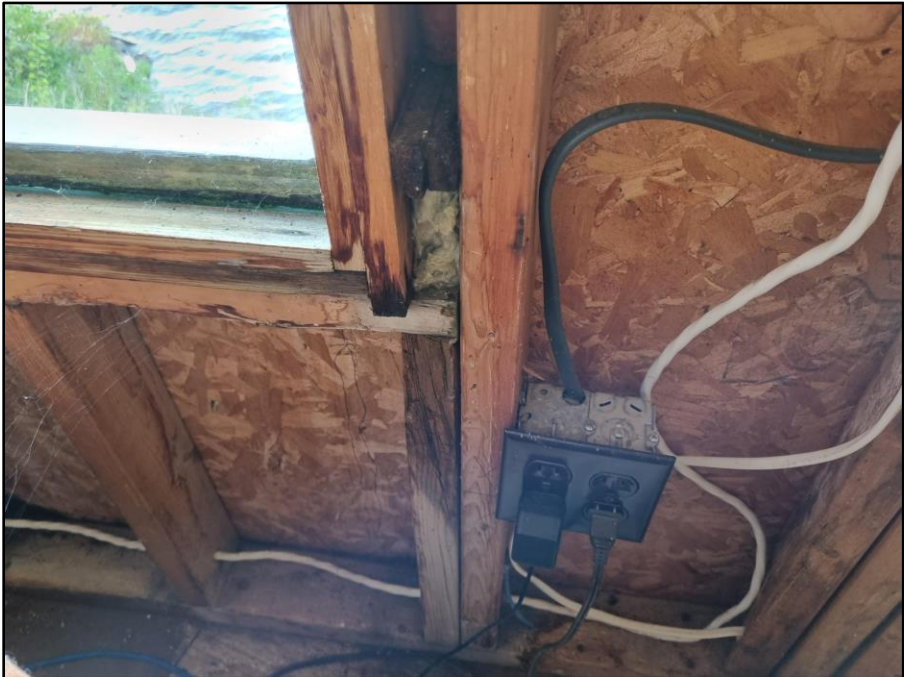
5. Most windows and the wood framing around the openings showed signs of long-term water damage / leaking and should be replaced. Refer to Photo 5.
6. The building envelope of the cottage was in very poor condition. Improper use and lack of vapor barrier, poor insulation, and old windows make any cold weather use unfeasible without moisture accumulating in the wall and ceiling cavities.

**Photo 5 – Leaking Around Window Framing**
