## STRUCTURAL ASSESSMENT REPORT

**Project:** Mowat Cottage Structural Assessment

**Project No.:** LE-0545-25

**Address:** 2089 White Lake Road West, Douro-Dummer, ON

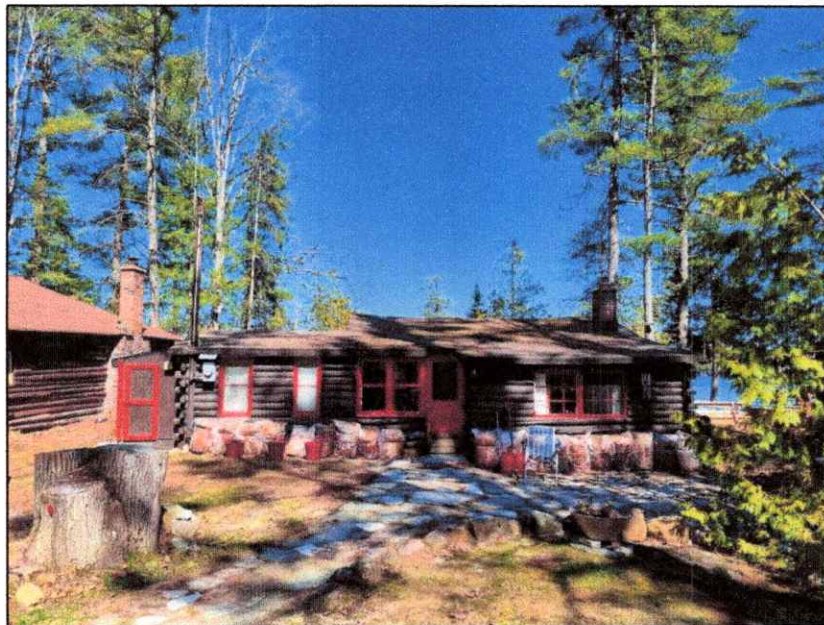
**Photo 1 - Existing Cottage**

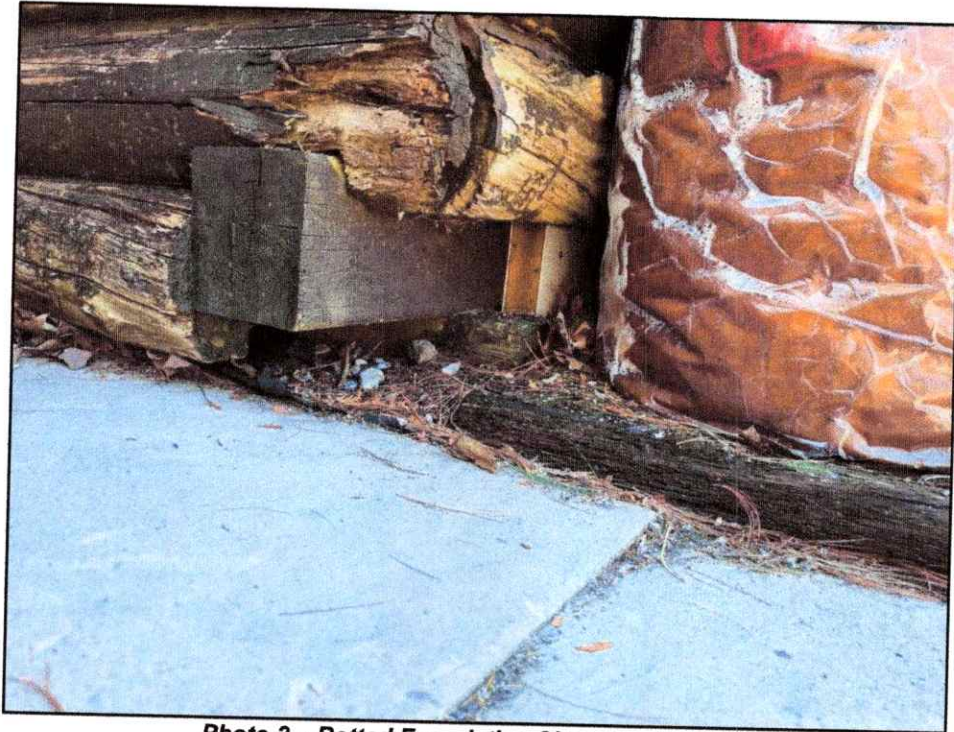
1. The wood foundation / main floor framing under the cottage is deteriorating. Lack of a proper foundation has led to sagging and settlement in the wood foundation which was evident inside and outside the cottage. The portions of the wood foundation that could be observed showed extensive rot. Refer to Photo 2.

*Photo 2 – Rotted Foundation Sleepers on Grade*

Based on our site observations, it is our opinion that the existing cottage cannot be repaired or renovated to a level of performance consistent with the Ontario Building Code without essentially rebuilding the entire building. We therefore recommend removing and reconstructing the building instead of attempting to renovate or repair.

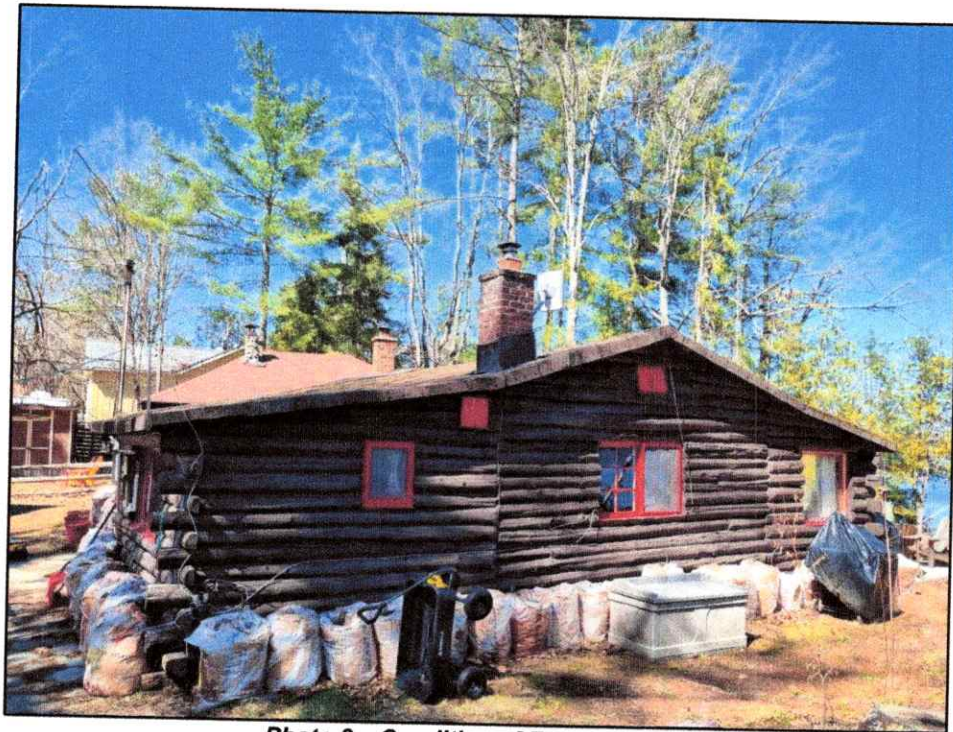
2. The wood walls appeared to be in ok condition but lacked insulation or vapor barrier which makes winter use unfeasible without creating moisture in the wall cavity. Bags of insulation were stacked around the building to help retain heat during cold weather. Refer to Photo 3.

*Photo 3 – Condition of Exterior Walls*

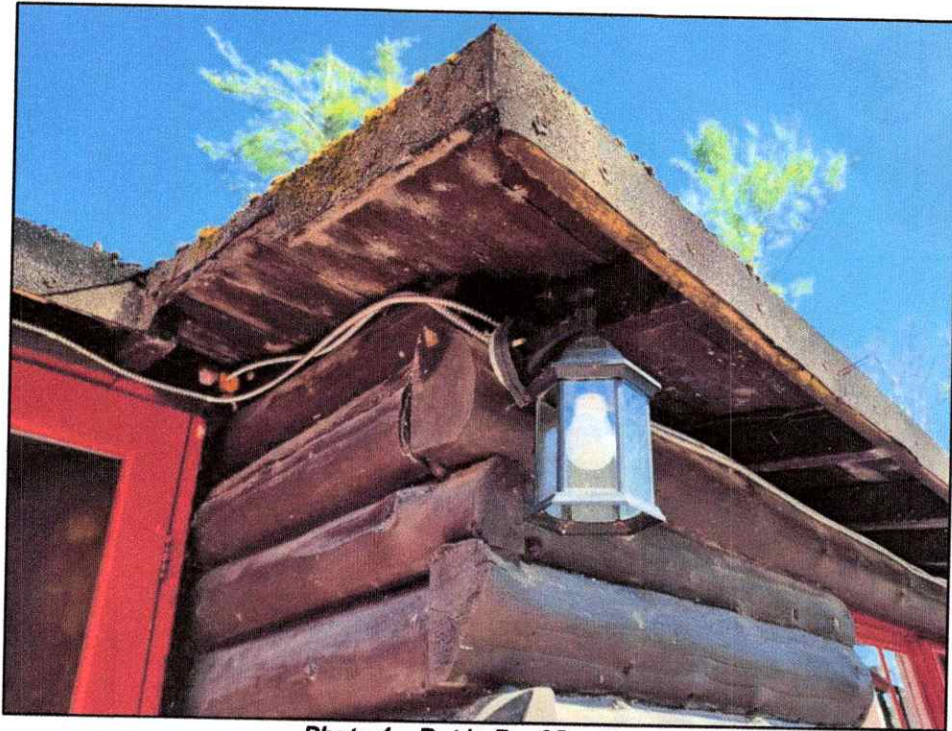
3. The roof framing showed severe sagging especially around the chimney area and over 50% of the roofing membrane was covered in moss due to rotting of the roof decking below. Lack of insulation or vapor barrier also makes winter use unfeasible without creating moisture in the ceiling cavity. Refer to Photo 4.

*Photo 4 – Rot in Roof Decking*
