Scoped Environmental Impact Study (sEIS) Proposed Cottage Rebuild 1604 Julia's Creek Road West, Stony Lake Part Lot 32, Concession 10 (Dummer) Township of Douro-Dummer, County of Peterborough

Oakridge Environmental Ltd.

Kevin Cowie 151 Macpherson Avenue Toronto, Ontario M5R 1W9 Project #: 23-3285

June 2023

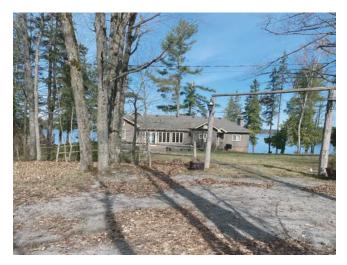
Photo A (Above): was taken looking north from the driveway toward the lakefront (in the background) at the existing cottage on the property.

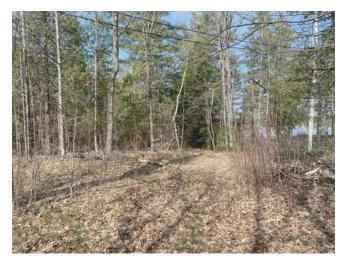
Photo C (Above): was taken looking southwest from the neighboring property to the south which is part of the property owner's land holdings in the area.

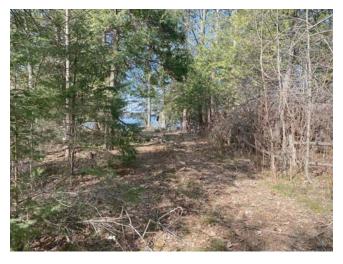
Photo D (Above): was taken along the southern edge of the subject property's limit looking west. The coniferous woodland habitat on the left side of the photo corresponds to the upland woodland habitat described in the Vegetation section of the report.

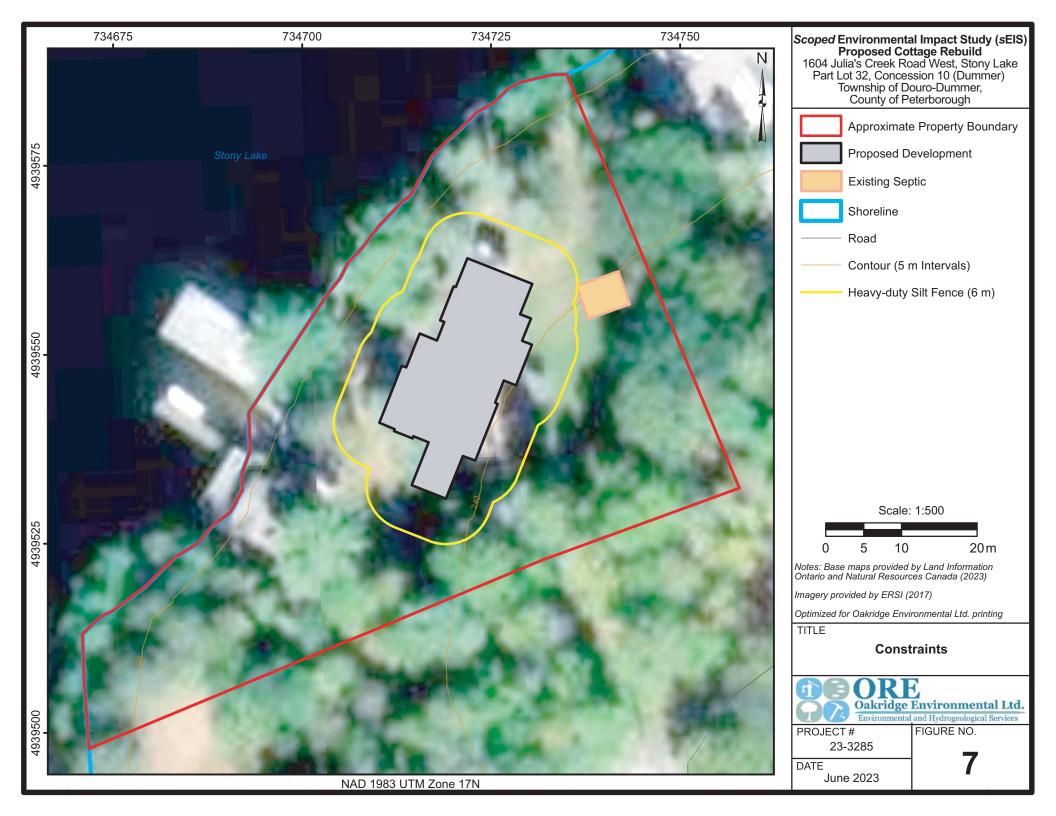
Our field investigations have confirmed that the main concern with respect to the proposed cottage rebuild is the location relative to the lakeshore (as illustrated on Figure 7). The removal/demolition of the cottage could result in a relatively large area of bare soils around the existing cottage being exposed adjacent to the lakeshore. That being said, it is expected that the majority of the construction zone will not expand significantly beyond the existing cottage footprint and driveway/parking areas. As such, the construction can be mostly confined to the existing area of disturbance on the lot.

- The proposed cottage rebuild should generally fit over the footprint of the existing dwelling, as illustrated by Figure 7, which also indicates the approximate limit of the *disturbance* / *construction area* defined by the yellow dashed line.
- As illustrated, the majority of the disturbance and alteration should be confined to the general area of the southwestern and southern edge of the existing cottage and the access trail to the cottage.
- Provided the authorities are in agreement with the proposal, the cottage rebuild can proceed with very little additional disturbed area occurring, other than some

- To ensure the development does not advance any closer to Stony Lake, a 6 m wide setback/buffer should be applied to the dwelling and demarcated on-site by installing a heavy-duty silt fence, as illustrated by Figure 7. This will prevent the construction crew from unnecessarily increasing the overall disturbance footprint in the area of the dwelling, especially when the use of heavy equipment is necessary. The heavy-duty silt fencing will ensure that any loose/ unconsolidated materials will not migrate beyond this limit, thereby protecting Stony Lake (considered a sensitive hydrological feature).

- To prevent machinery from unnecessarily advancing toward the waterfront area, the heavy duty silt fence should extend off the 6 m shoreline to the north and encapsulate the existing dwelling. In doing so, this will provide a clear construction limit on-site while cordoning off the entire work area. By installing the fence and applying the 6 m work zone setback off the dwelling, it will ensure the work area is contained around the existing cottage.

- The design/layout plan for the rebuild should demonstrate that the work can be completed within the 6 m wide work zone illustrated on Figure 7 (Constraints). The site plan should illustrate which native shrubs will be planted on-site to improve the shoreline conditions. It may be possible to direct a few of the native plantings in the disturbed area associated with the newly renovated cottage for shade purpose or to reduce lawn areas on the property. The planted trees/shrubs can become part of the landscaping plan.
