Scoped Environmental Impact Assessment (sEIA) Proposed Canoe Storage Building 1076 Duck Pond Lane, Stony Lake Part Lot 33, Concession 7 (Dummer) Township of Douro-Dummer, County of Peterborough

Re: Scoped Environmental Impact Assessment (sEIA) Proposed Canoe Storage Building 1076 Duck Pond Lane, Stony Lake Part Lot 33, Concession 7 (Dummer) Township of Douro-Dummer, County of Peterborough ORE File No. 23-3316

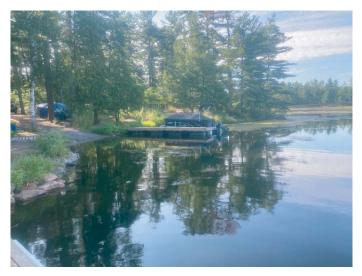
Photo A (Above): was taken looking southeast from the dock that occurs offshore from the cottage. Can see clearly where the open water and PSW floating leaved aquatic areas are in photo.

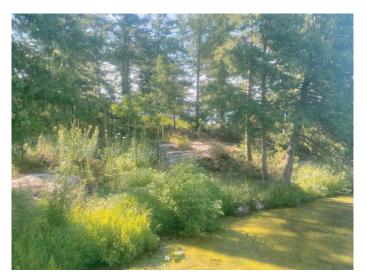
Photo B (Above): was taken looking southwest across the waterfront directly downgradient of the proposed boat storage building.

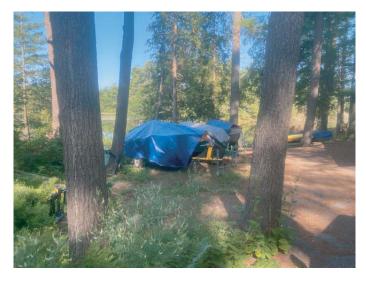
Photo C (Above): was taken looking west towards the area where the boat storage building is to be located, just beyond the large diameter pine.

The proposed canoe storage building is to be constructed within an opening directly southwest of the existing garage. However, it is not an area that is frequently used/disturbed to access the existing buildings on-site. There is an existing track-bare laneway that occurs directly south of the existing garage that allows the owner access to the lakeshore for the purpose of launching boats.

It is within this habitat that the proposed canoe storage building is to be constructed. According to the site plan, no mature trees occur directly within the proposed building envelope.

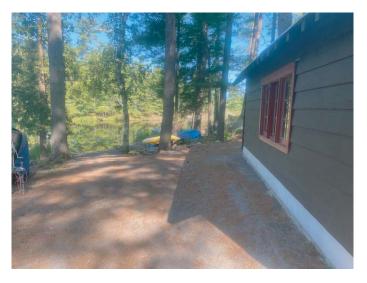
Photo D (Above): was taken looking west along the south side of the existing garage. It illustrates the existing laneway that most of the machine operated work can be conducted from to construct the boat storage building.
