**Re: Slope Stability Inspection at 1182 Birchview Road, Lakefield, Ontario**  
**Cambium Reference: CAM23286.001**

**SLOPE STABILITY ANALYSIS**  
**WELSH HOMES**  
 1182 Birchview Road  
 Lakefield, Ontario

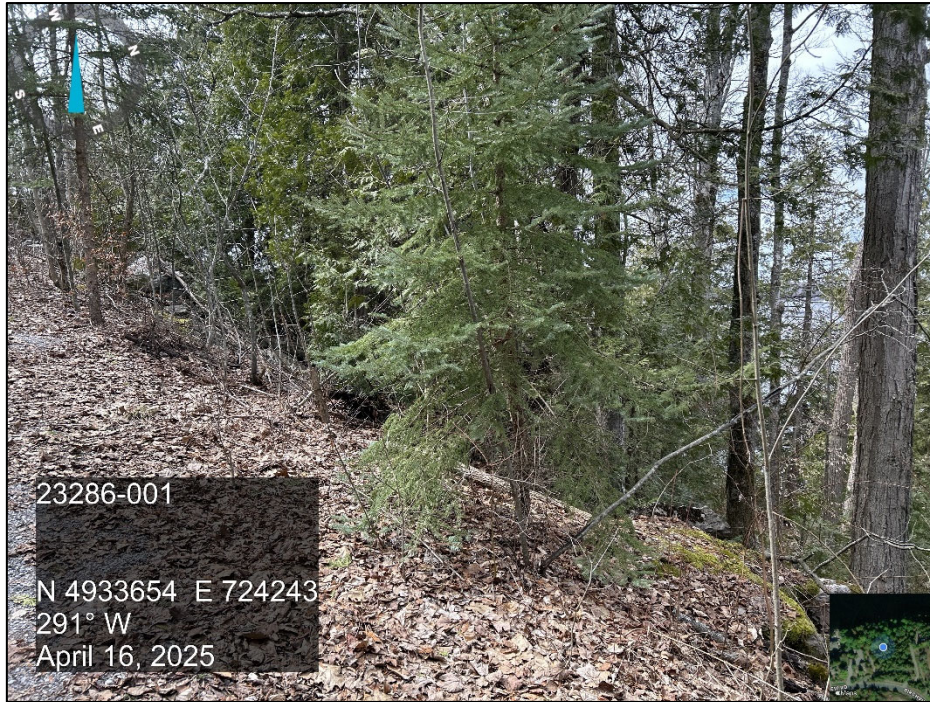
**Photo 1** View of the top of the middle slope at Cross Section A-A, looking west. Showing the driveway, mixed mature trees along the slope crest.

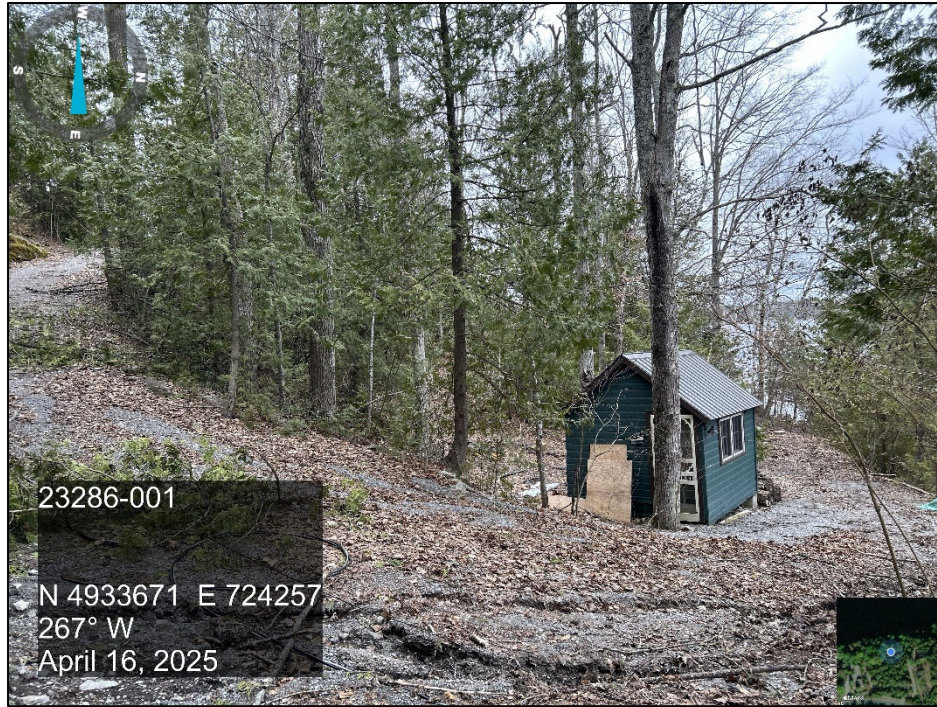
**Photo 3** View of middle slope face near Cross Section A-A and B-B, looking west, showing the driveway, shed structure and mixed mature trees.

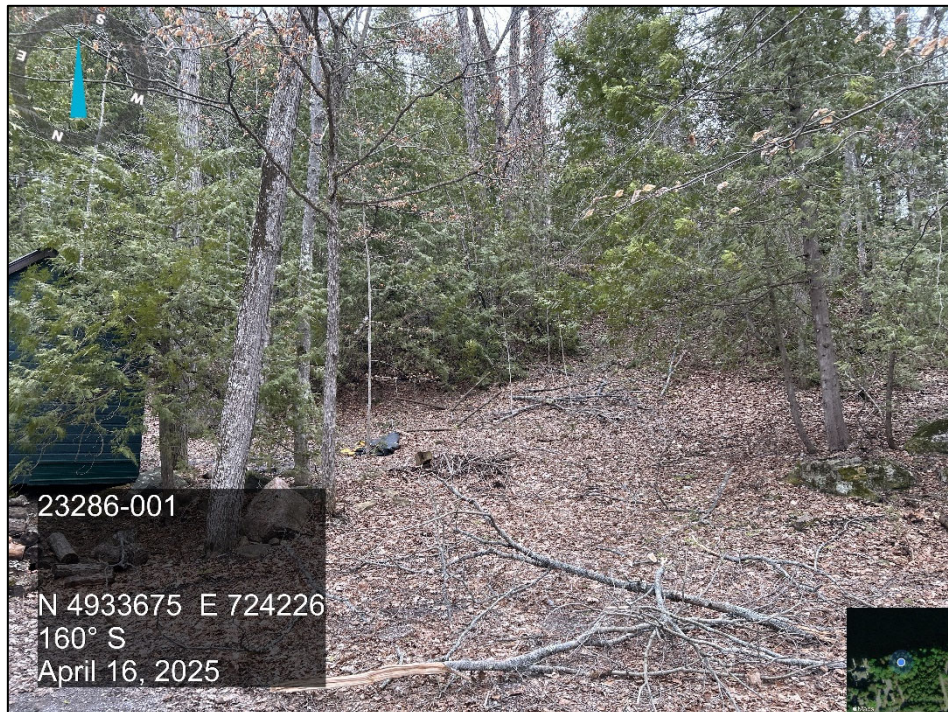
**Photo 4** View looking up the middle slope from near the base of the middle slope at Cross Section A-A, looking south, showing mixed mature trees.

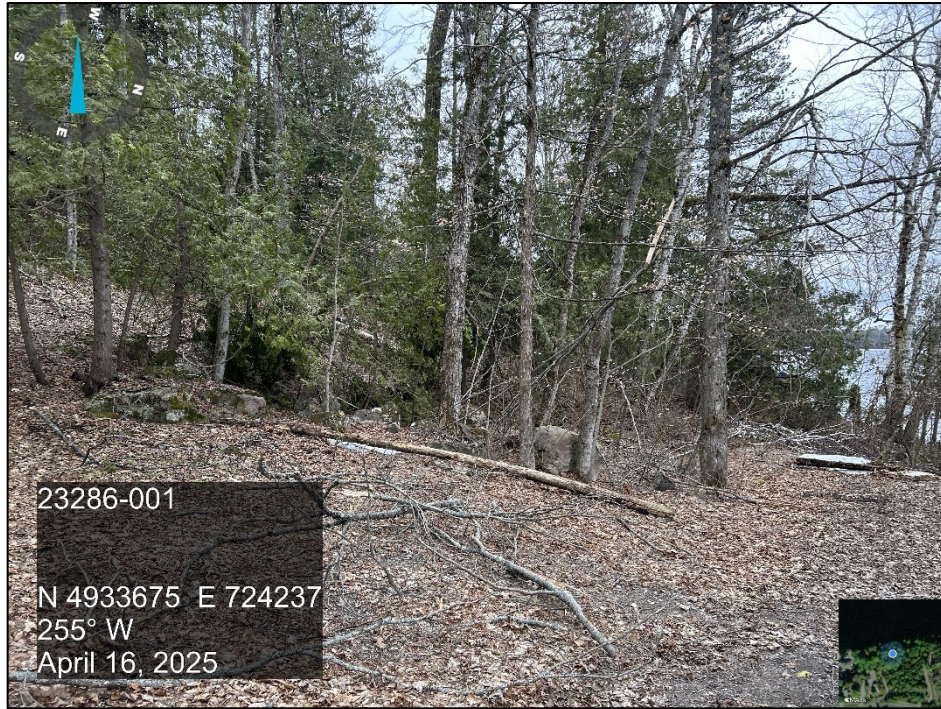
**Photo 5** View of the bottom of the middle slope and the lower slope at Cross Section A-A, looking west. Showing the driveway, mixed mature trees, and Clear Lake.

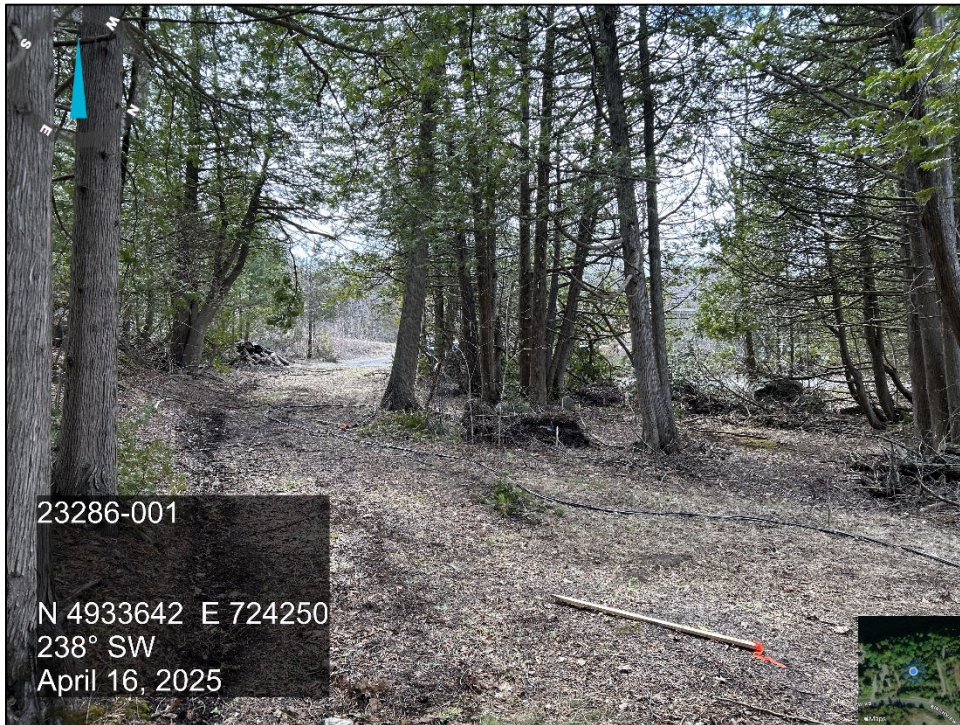
**Photo 8** View of the bottom of the upper slope and top of the middle slope near Cross Section B-B, looking southwest, showing the driveway and mixed mature trees. The upper slope at Cross Section A-A is evident in the background.

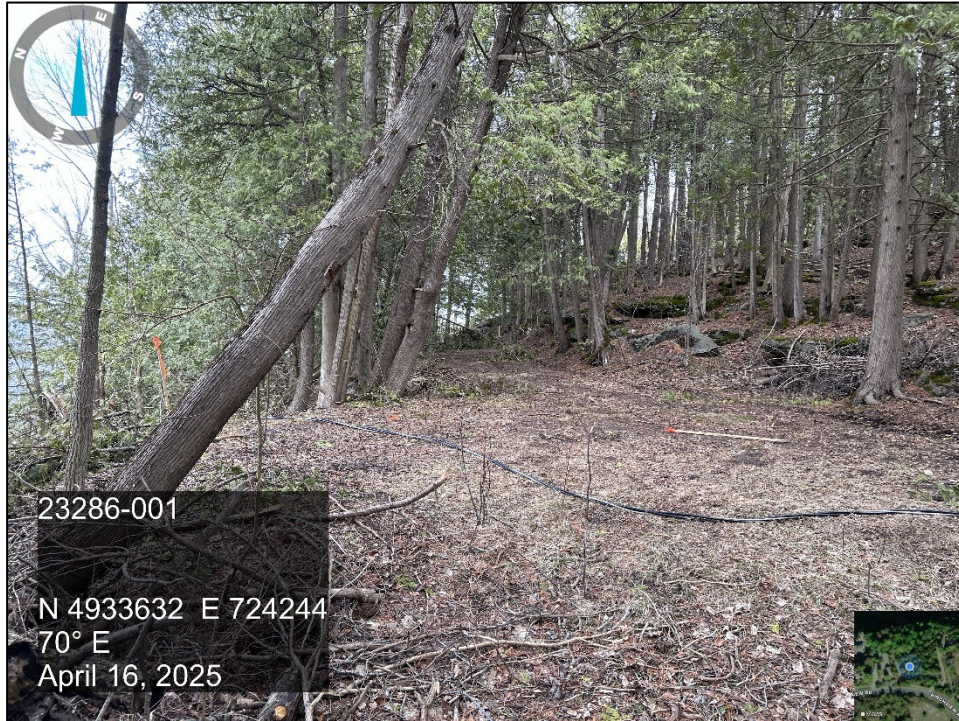
**Photo 9** View of the top of the middle slope at Cross Section B-B, looking east. Showing mixed mature trees.

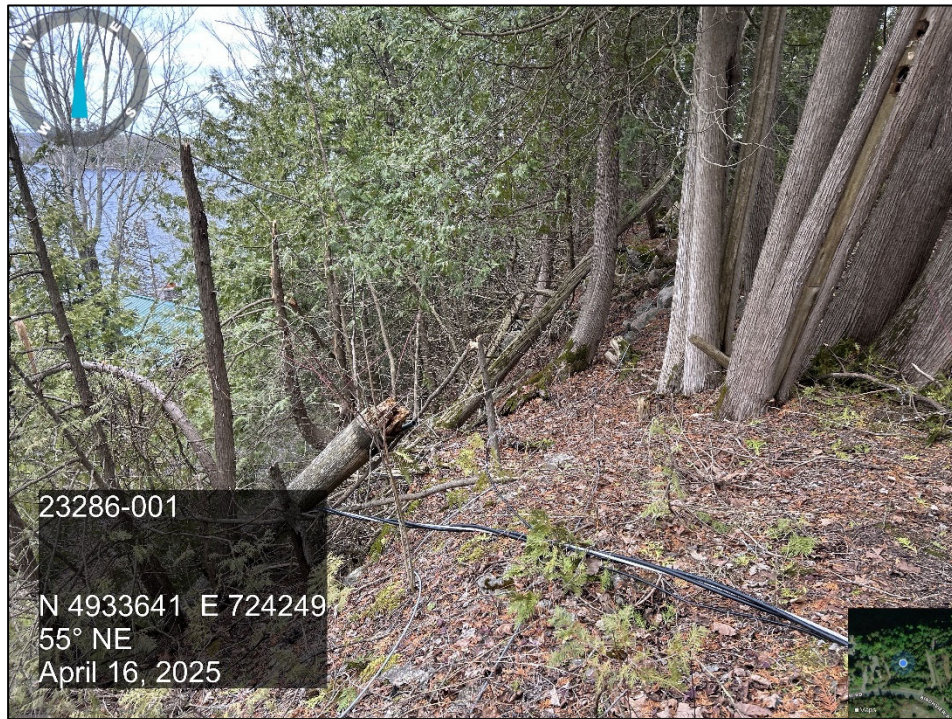
**Photo 10** View of the crest of the middle slope at Cross Section B-B, looking northeast. Showing mixed mature trees and the existing residential structure.

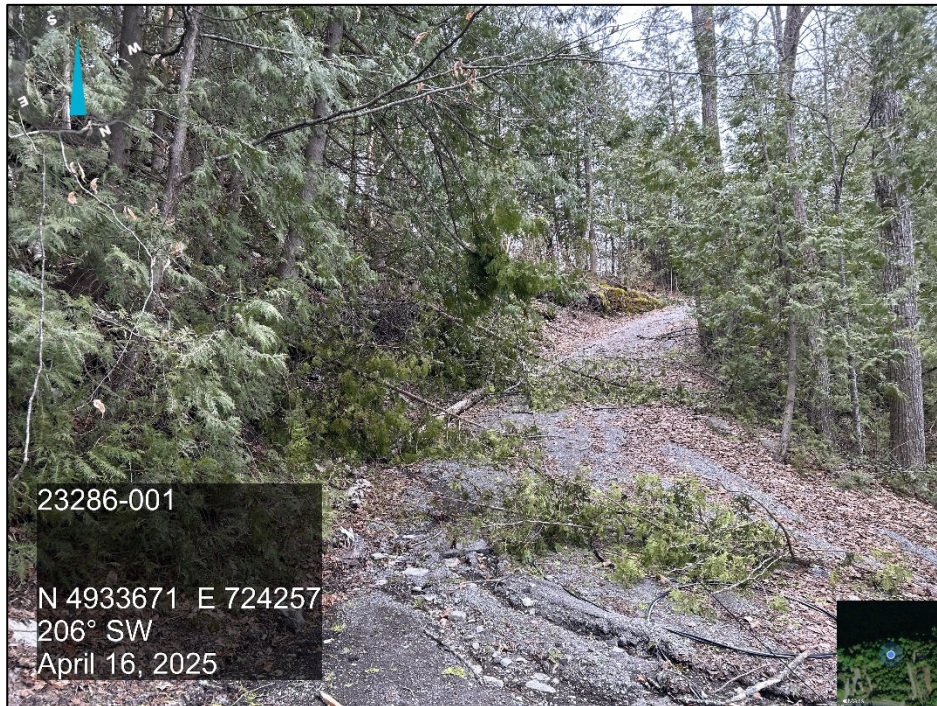
**Photo 12** View of middle slope face near Cross Section B-B, looking southwest, showing the driveway and mixed mature trees.

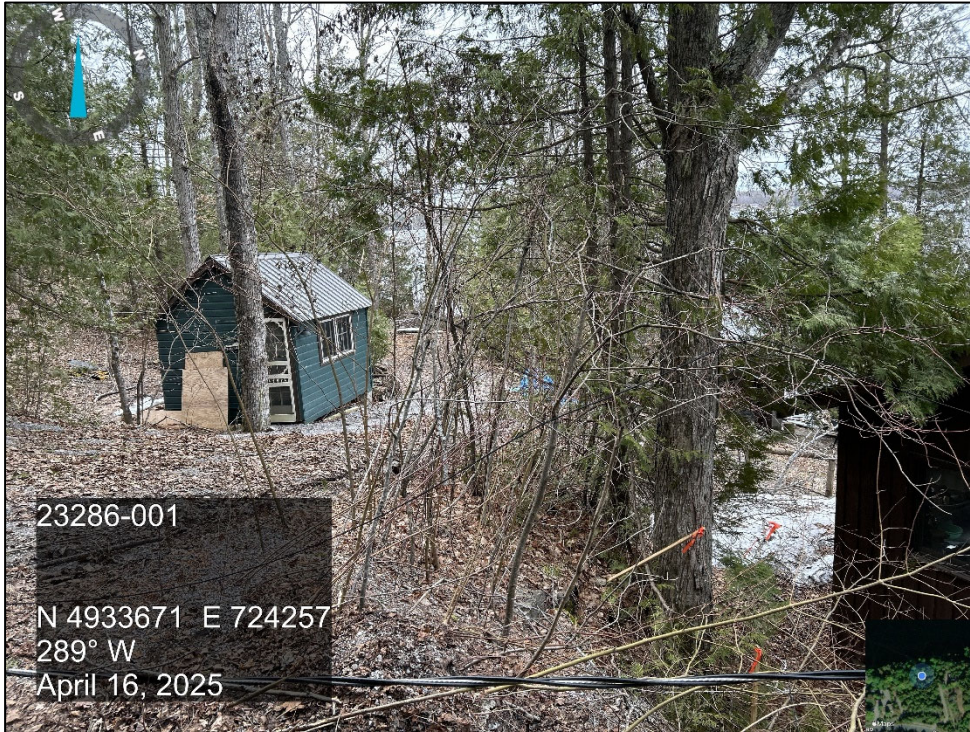
**Photo 13** View of the bottom of middle slope face and top of the lower slope near Cross Section B-B, looking west, showing the driveway, shed structure, residential structure, and mixed mature trees.

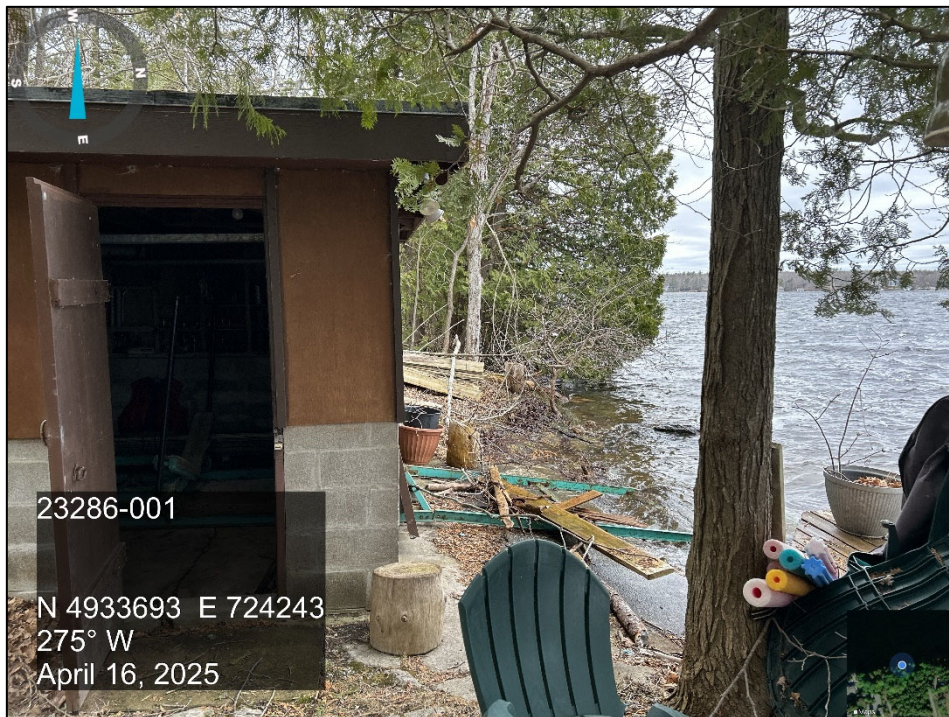
**Photo 14** View of the bottom of the lower slope near Cross Section B-B, looking west, showing the boathouse structure, Clear Lake, and mixed mature trees.

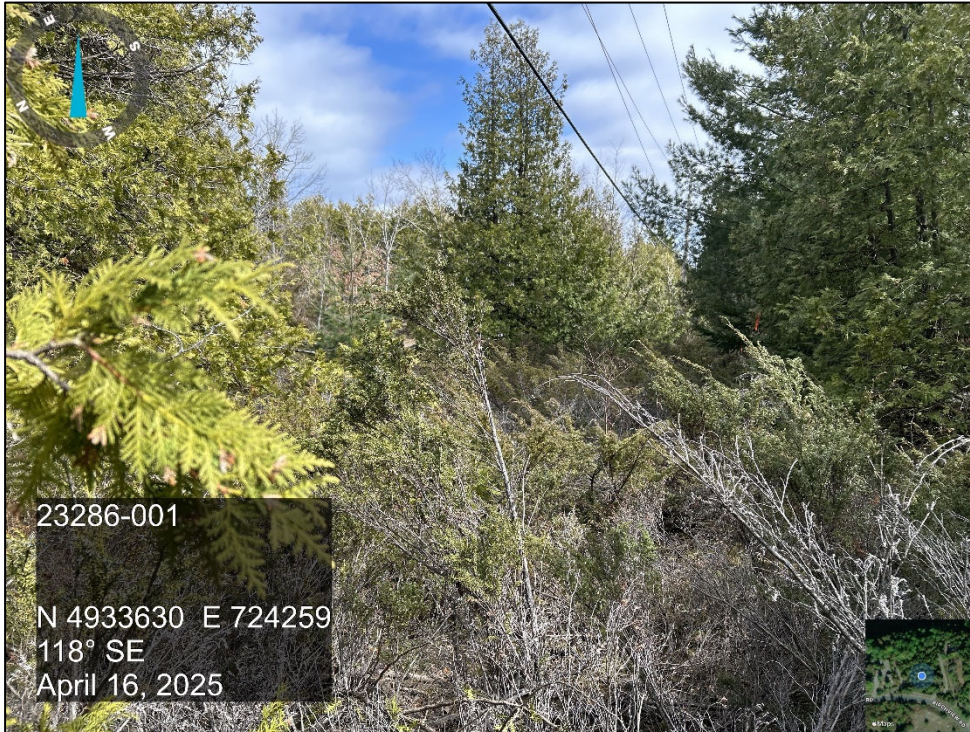
**Photo 15** View of the top of slope at the upper slope at Cross Section C-C, looking southeast, showing mixed mature trees, and hydro lines.

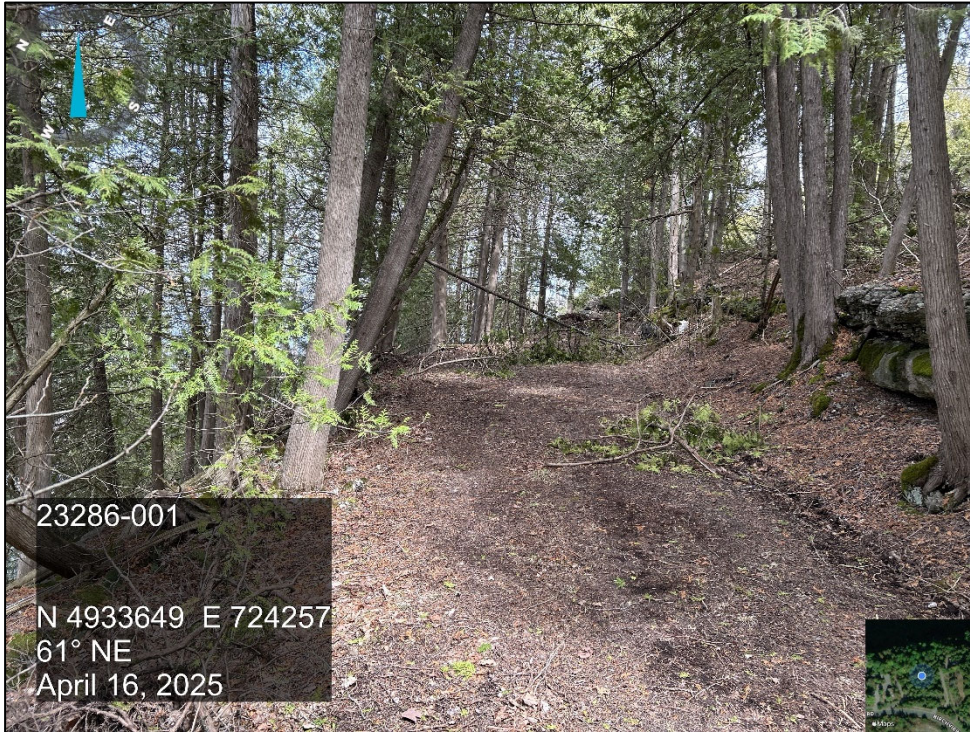
**Photo 17** View of the bottom of the upper slope and top of the middle slope at Cross Section C-C, looking northeast. Showing mixed mature trees.

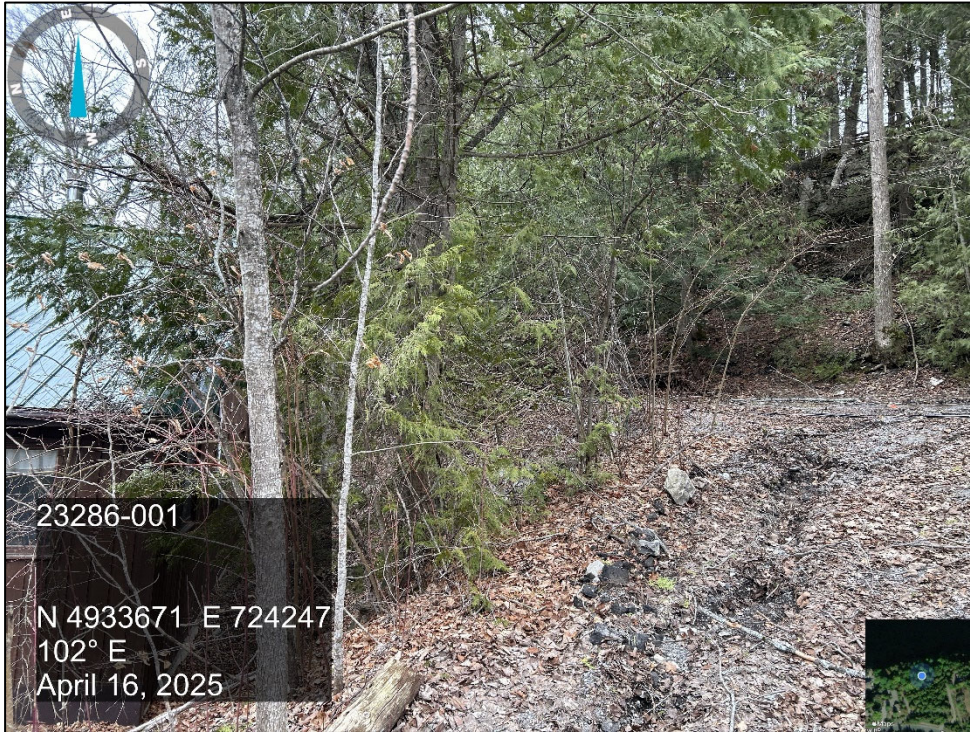
**Photo 19** View of the bottom of middle slope face and top of the lower slope near Cross Section C-C, looking east, showing the driveway, residential structure, and mixed mature trees.

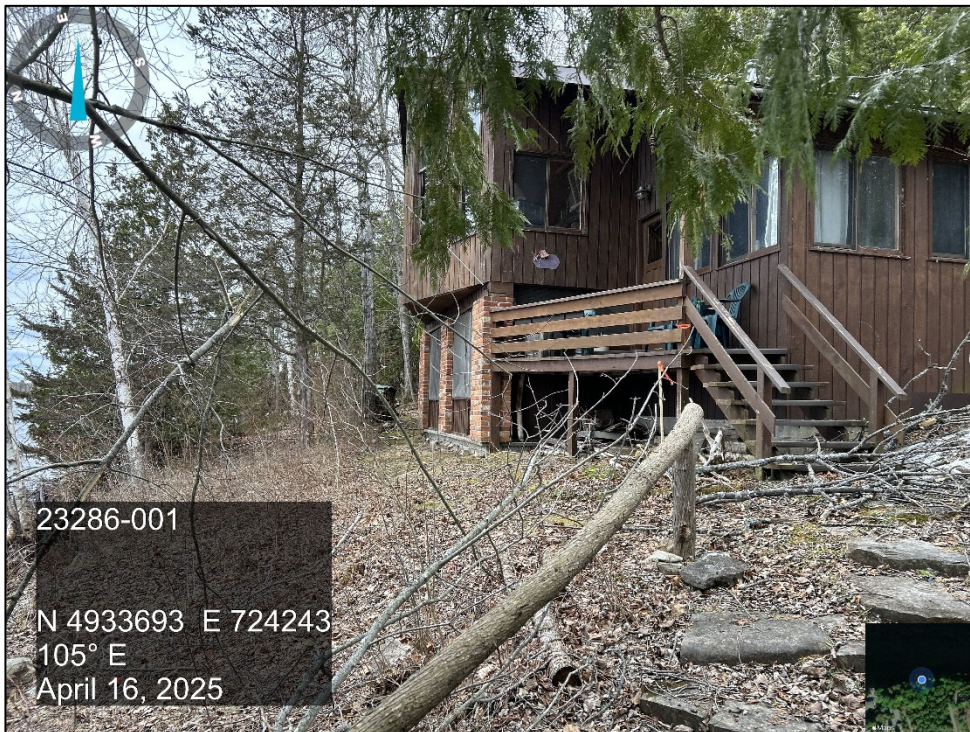
**Photo 20** View of the lower slope near Cross Section C-C, looking east, showing the residential structure, Clear Lake, and mixed mature trees.

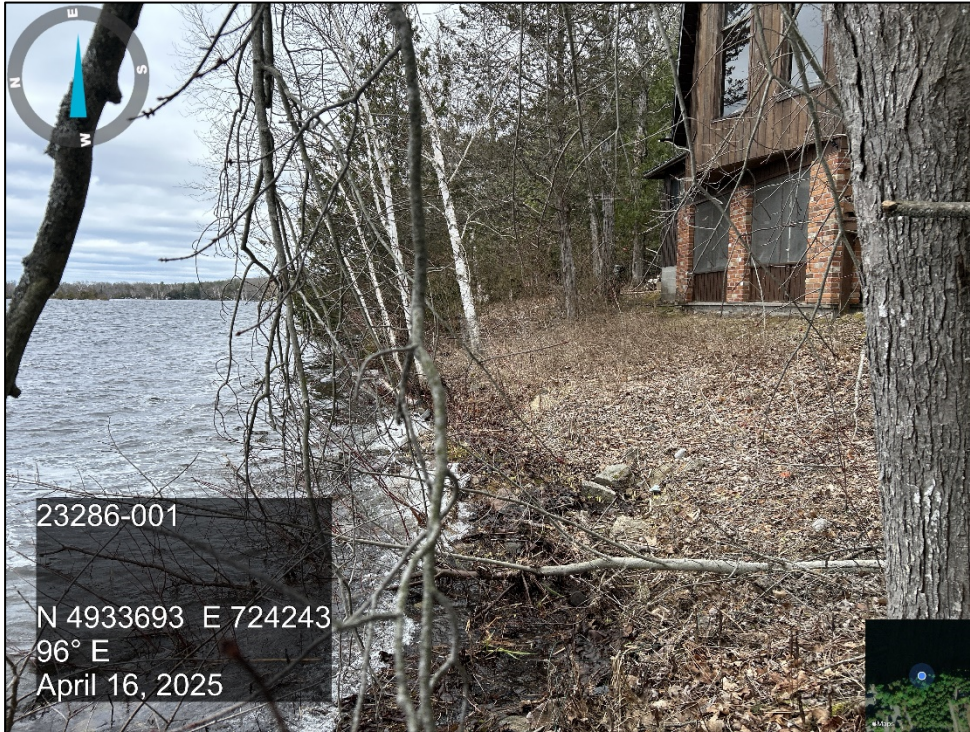
**Photo 21** View of the bottom of the lower slope near Cross Section C-C, looking east, showing the residential structure, Clear Lake, and mixed mature trees.

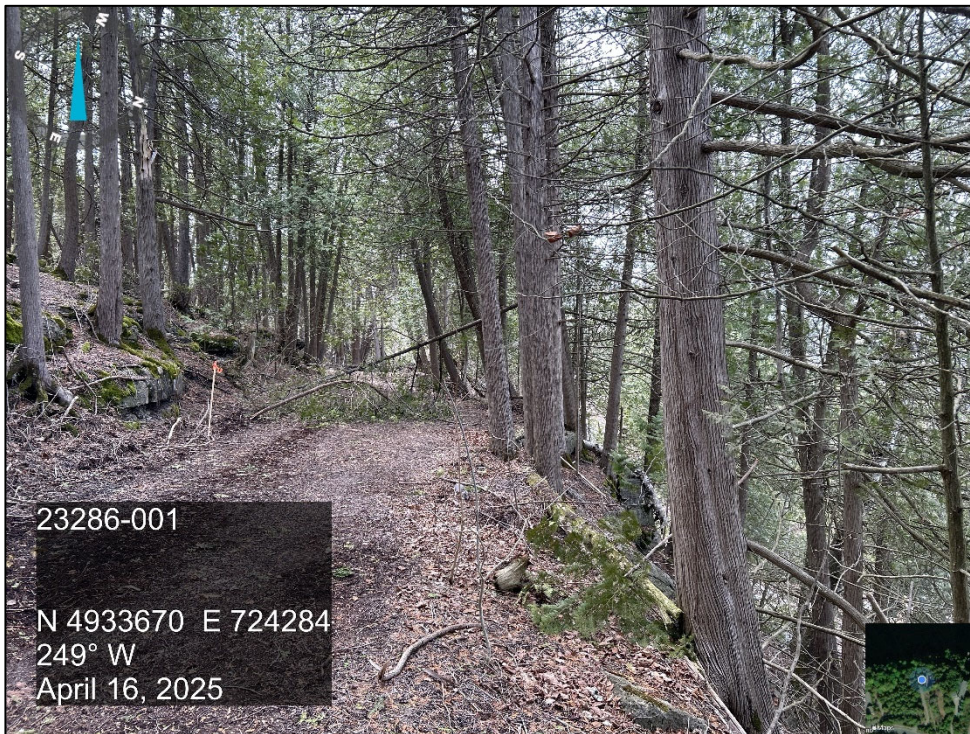
**Photo 24** View of the bottom of the upper slope and top of the middle slope at Cross Section D-D, looking west. Showing mixed mature trees.

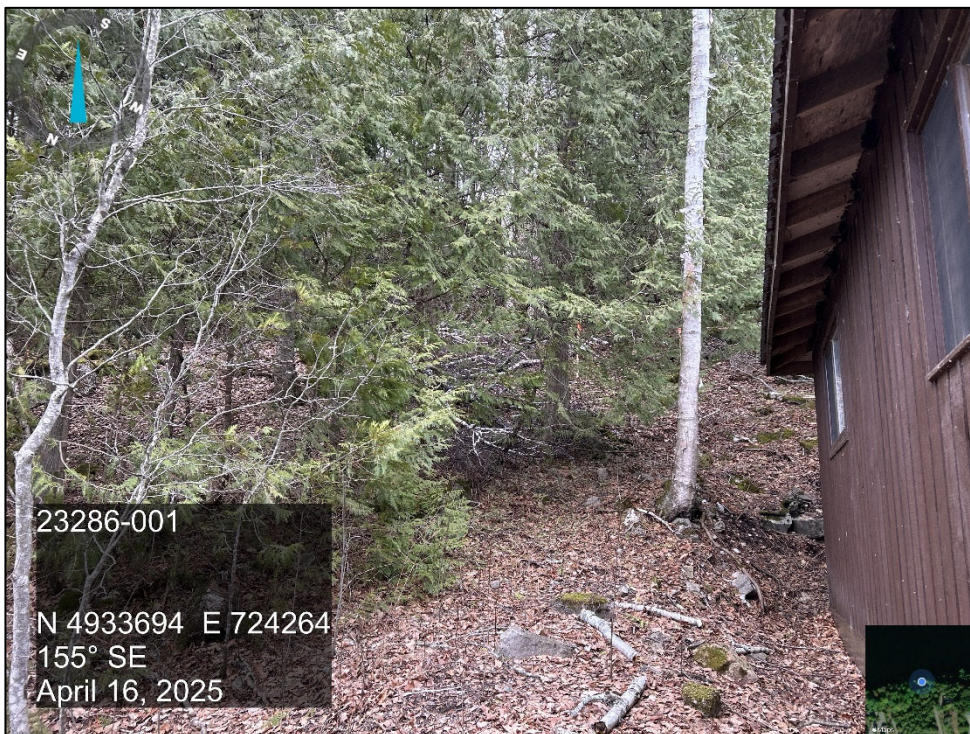
**Photo 26** View of middle slope face from the base of the middle slope along Cross Section D-D, looking southeast. Showing residential structure and mixed mature trees.

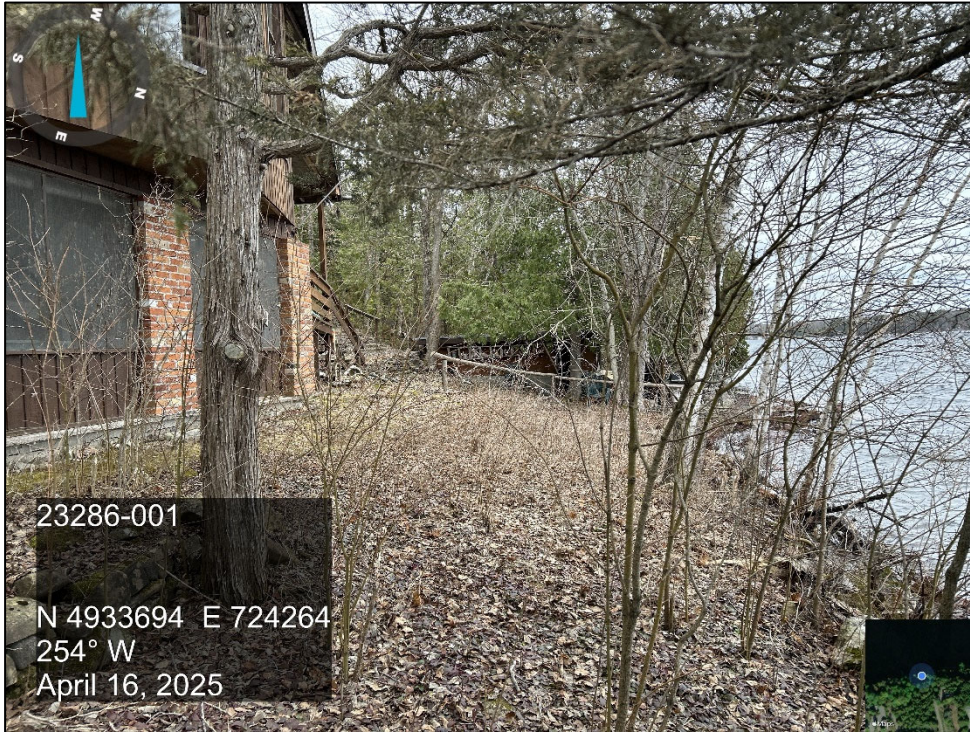
**Photo 27** View of the bottom of the lower slope near Cross Section D-D, looking west, showing the residential structure, Clear Lake, and mixed mature trees.
